PB46CUG04X-3-7AAG

8D FA report

What happened	喇叭無訊號
When detected	2019/07/03
Where detected	Production Assemble line
Why detected	One speaker function test no signal
How many	1 PCS
How detected	Remove Speaker and Wire cold soldering of black wire to pin

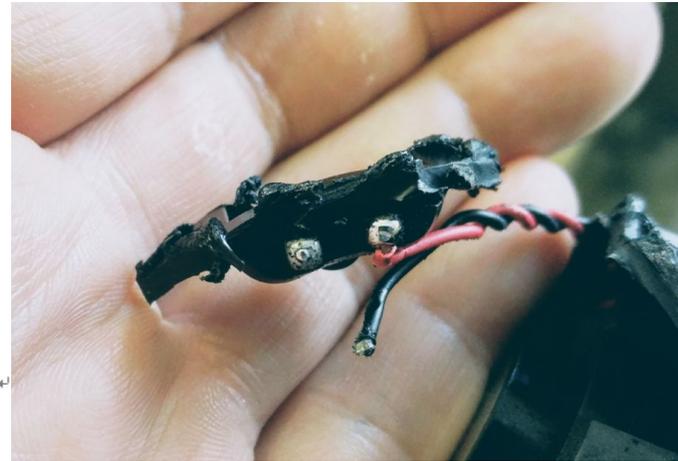
Now we assembling P46 speakers we got. (我們開始組裝 P46)
Production line test each speaker after assy cable. (產線焊接後檢驗每個喇叭)
They found one P46 with no signal. (其中一個無訊號)
Open this P46 to find out the problem. (試著打開機殼)
Speaker head is OK, wires black & red are OK. (喇叭頭是好的, 黑紅線也是好的)
Problem is cold soldering of black wire to pin! (問題點在於黑色線冷焊)
So this wire was in the open air and has no contact to pad. (如附件, 並未焊接在 PAD 上)
Picture is in attach.

Then try to heat pin with red wire and pin was melt out from plastic but red wire was soldering well to pin.
Please ask VECO to pay more attention for cold soldering of wires to pins because it is very critical parameter. (日後生產請務必注意冷焊、空焊問題)
If we test speaker and all be OK but after install in the car it will defect we will have a BIG BIG problem with that. (若日後組裝在車體內仍有此現象會造成很嚴重的問題)

1. Operator is not so good skilled need to training
2. Operator pull or remove wire during soldering
3. Solder head, leave too much tin without clean
4. Although testing voice pass well, but cold sold cause parts wire remove during transpotation

>1: Check the soldering bit and the wire in the beginning, as soldering wire, bare wire of the connector must solder into tin. It should stay for 2S when finish one side, while the other side become cold than solder it. To do this is to prevent one side not cold enough and to affect the connection of the solder. After soldering, put the speaker on the tooling (do not hold the wire) then to work on the flowline.
