Coils deformation
Wire rod mill - Ostrava

Team 3: Dmitriy, Marek, Mateusz, Jacek, Karine.

How can we decrease the occurrence of physical deformation of wire coils during collection and binding?

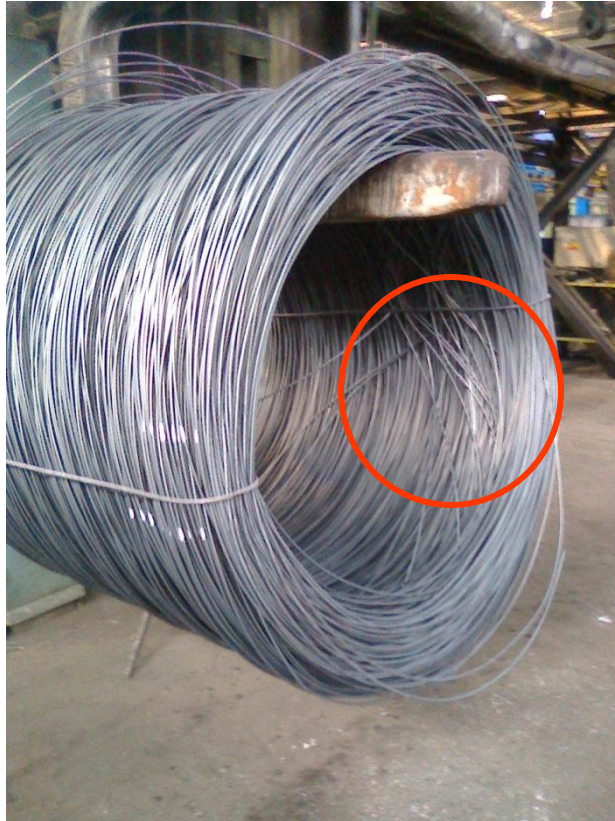
Description of the problem: Deformation of coil

- In 2015, 2.1 % of the total production is affected by this quality defect. Analysis per criteria not done (data per line, steel grade, ... not available);
- Mostly, the inner part of the coil is affected. No specific position identified (data not available);
- The problem is expected to occur during collection of the wire (gap between bell and thorn). Problem is random, no frequency linked with particular event (ie maintenance event).

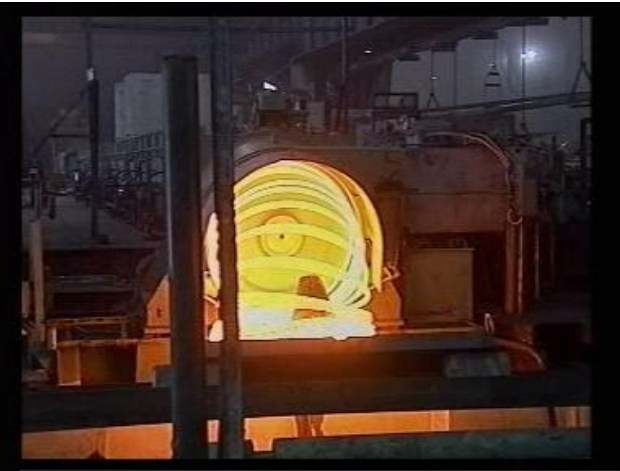
Design\Laying head.

Problem	Action
Laying head isn't tuned, relates to the diameters of wire.	Establish SOP (Standart operation procedures) for tuning of lying head, relates to the \emptyset of production wire, for avoiding of the separated coils.

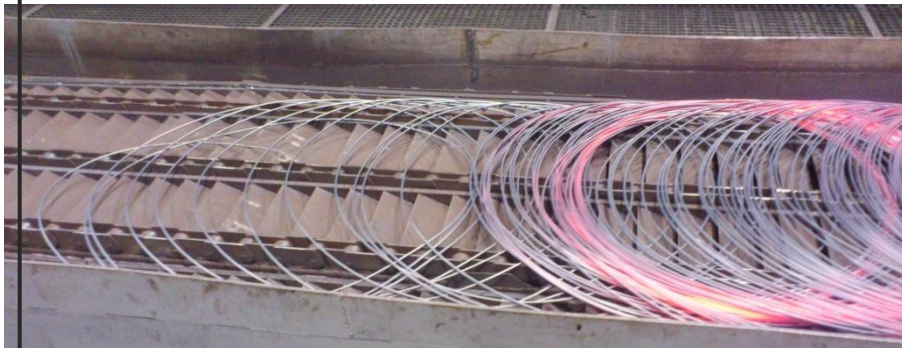
Laying bed "B"

separated coils are formated in line "B".

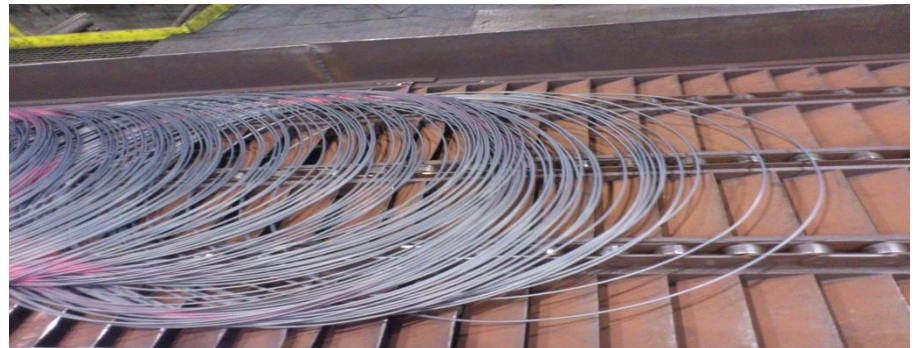
Laying bed "A"

separated coils are not formated in line "A".

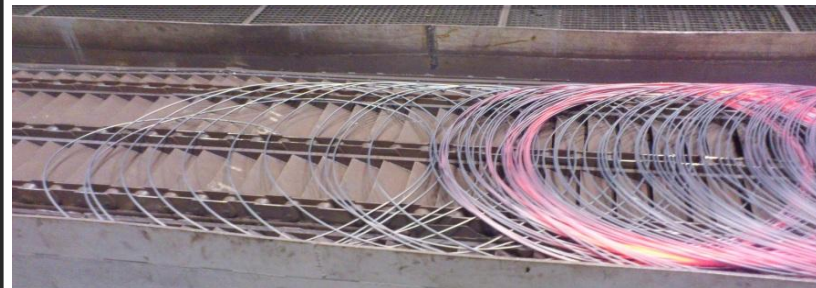
Speed of all f these parts aren't synchronized between each other, what can the problems with formation of separated coils.

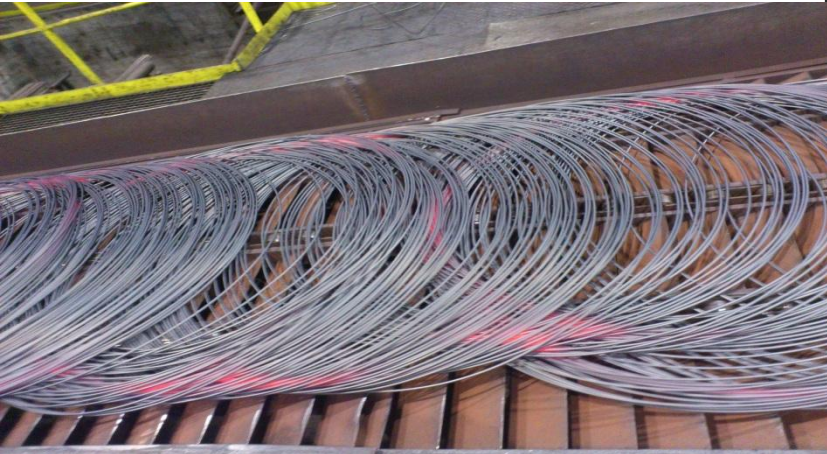
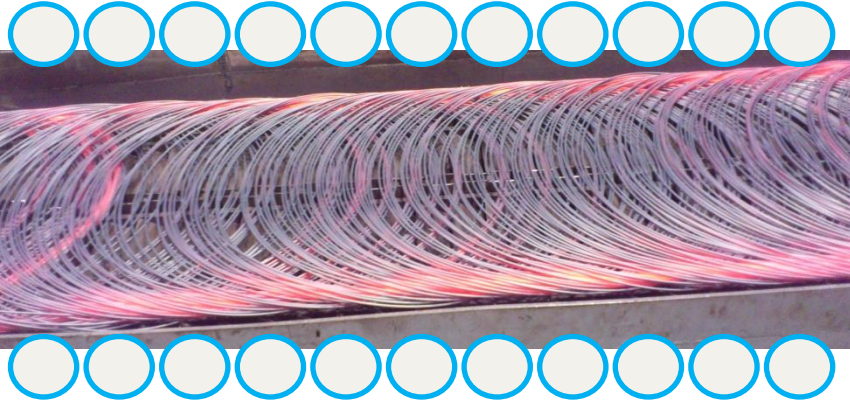
<p>Along the cooling bed some coils go with differences on the edges.</p>	<p>Along the whole transporter coils must go without any differences on the edges. Our proposal to implement guides (rolls or stands).</p>

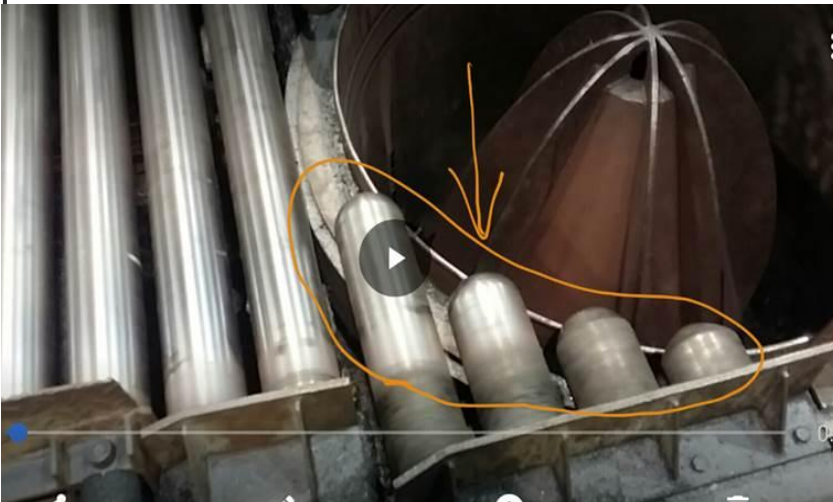
Collecting of coils, isn't tuned due to diameters and do not going exactly to the centre of the thorn.

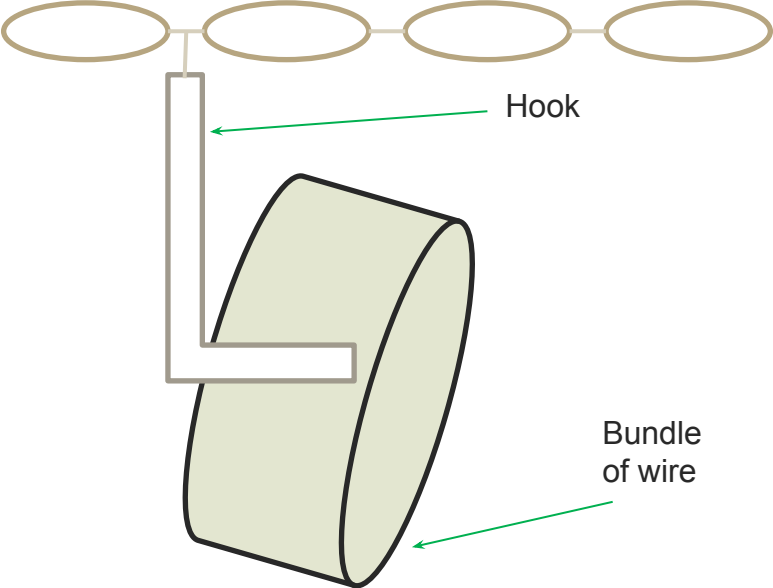
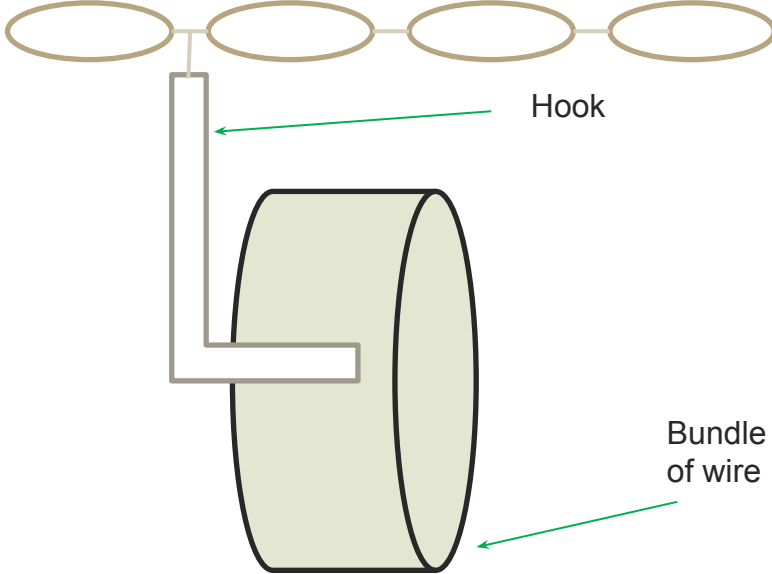
<p>Bundle of wire is transported to the hook under some angle.</p>	<p>Bundle of wire must be transported under the straight angle, for avoiding its movements.</p>

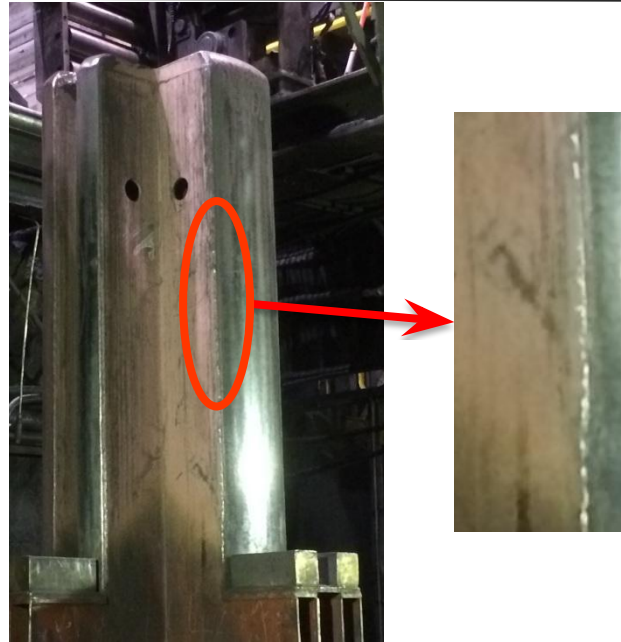
Surface of thorn contact point with inside of the coil is the rough.

Establish SOP (***Standart operation procedures***) for thorn grinding frequency.
