# Root Cause Analysis (Tube Bundle)

# Tube Bundles Progress Report

# Transshipment operations in Nogliki & Damage Report

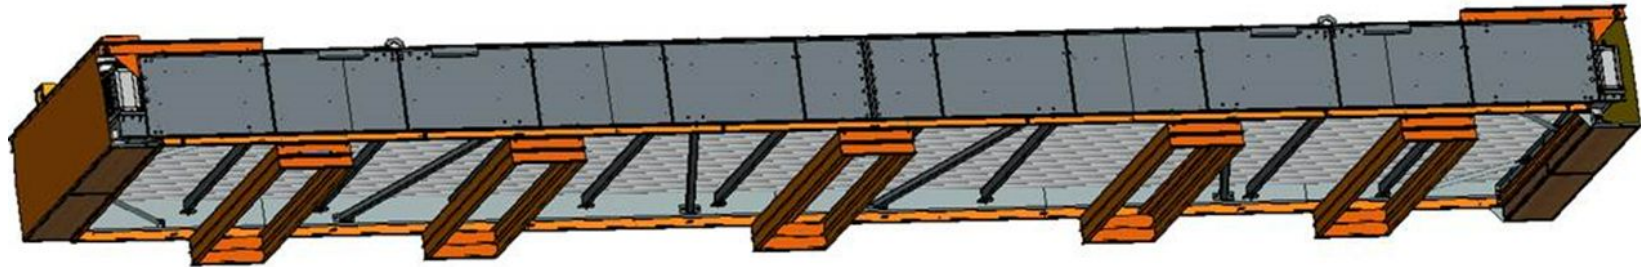
BHM made variations in tube bundle packing, only top protection provided. As well, BHM removed plywood sheets from the bottom of frame.

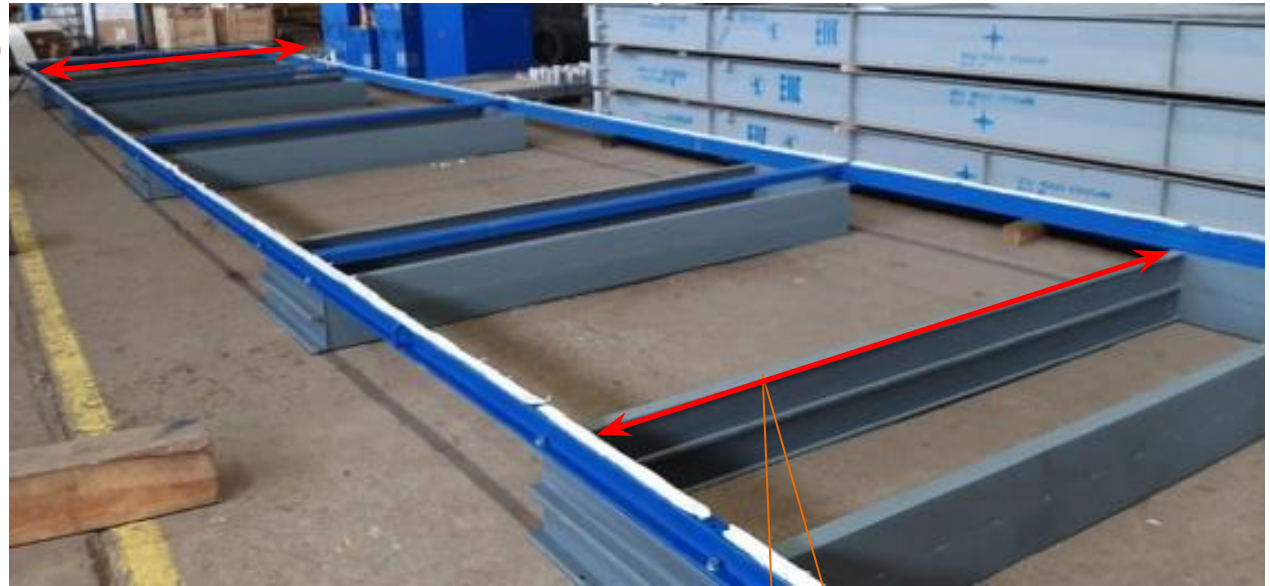
**Tube Bundle Frame** consists of **5 C-channel supports**  
On Picture highlighted the current design of tube bundle frame

- Missing transversal beams No. 1 and 5 in frame over the support beams and in the lashing points to distribute the weight.
- No 100% overlap: C-Chanel frame shorter than C-Chanel of support

No transversal beams over supports to distribute the weight

No 100% overlap: C-Chanel frame shorter than C-Chanel of support

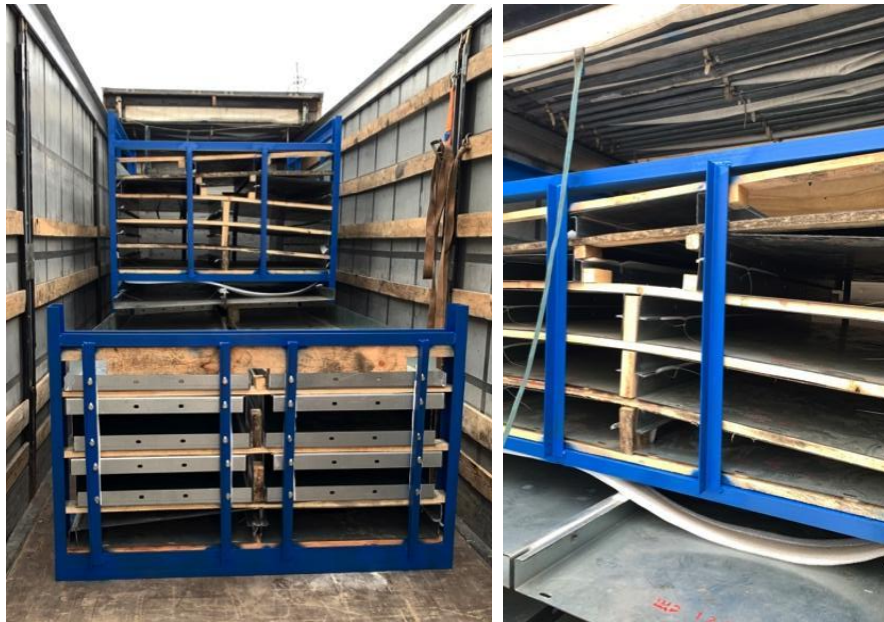
### Package A-070-153

Package arrived to Saratov terminal with the cargo visibly damaged. Packages itself remained firmly lashed and did not move during the road transport. The wall sheets were not properly secured against transversal and longitudinal movements. Package shipped back to BHM and package design was re-worked by BHM

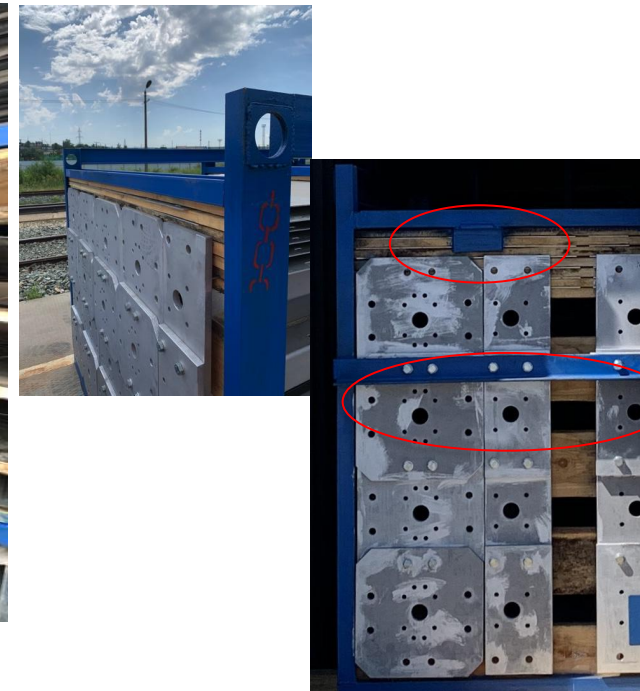
### Package A-070-113

Package arrived to Saratov terminal. Upon inspection with rail authorities the questions were raised whether current securing of the cargo inside the frame is sufficient. Kerry addressed the issue to BHM asking to re-check the calculations. Upon rechecking package was deemed not transport worthy and shipped back to BHM. package design was re-worked by BHM before shipping.

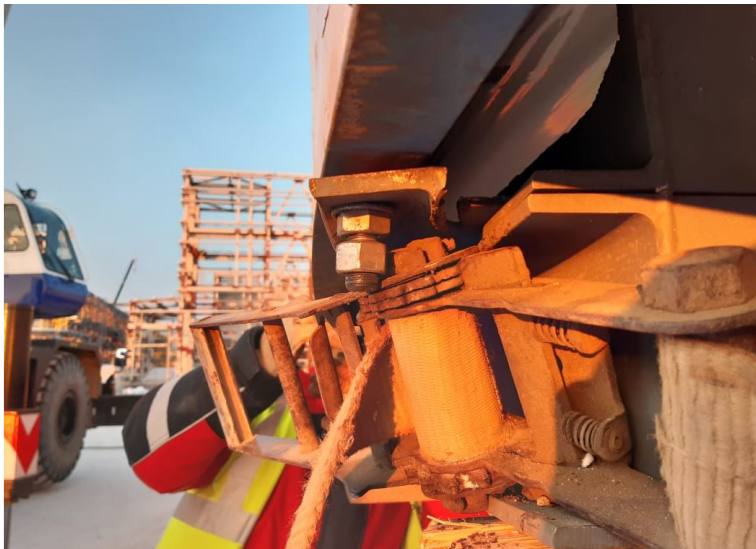
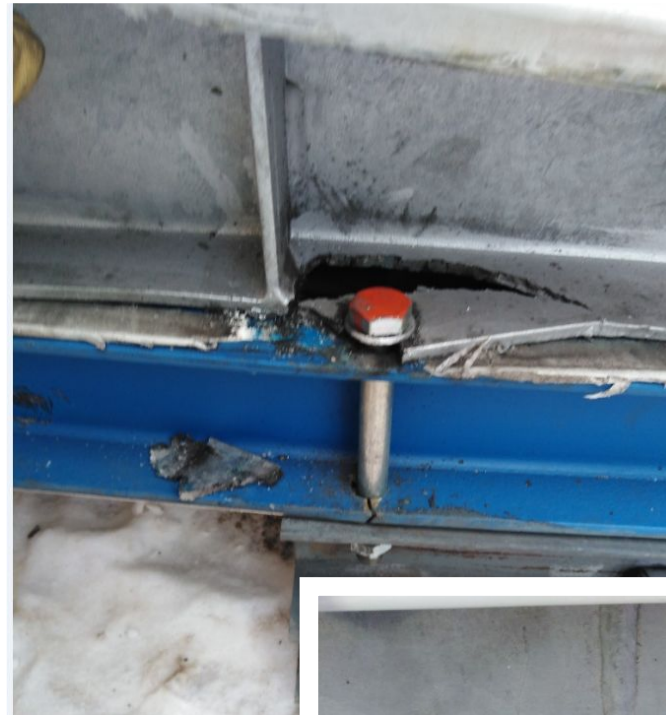
Full weight of the tube bundle frame is distributed on the supports' short side of the C-Channel

Short side C-Channel receives excess bending force under transport movement

Short side C-Channel cracks and then collapses dragging tube bundle down.

Collapse of tube bundle on the right side of loading frame support created excessive pressure on the bolts left side which resulted cracks

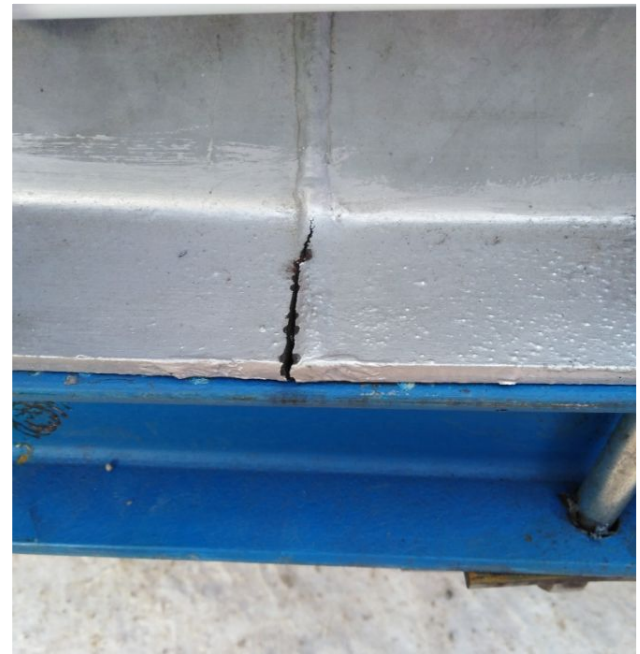
Tube bundle #93 support #1 damage

- There are no transversal beams to distribute tube bundle frame load on the supports;
- Support design relies only on bending stress, not on bearing stress;
- C-shape channel does not function properly due to lack of 100% overlap;

1. Suspension of loading & dispatch operations of tube bundles until BHM will re-visit structural analysis (calculations) Reinforcement of the supports and additional structural analysis
  - a. Reinforcement plates welding (see below)
  - b. Reinforcement backbone welding (see below)
  - c. Additional Transversal beams in transport frame

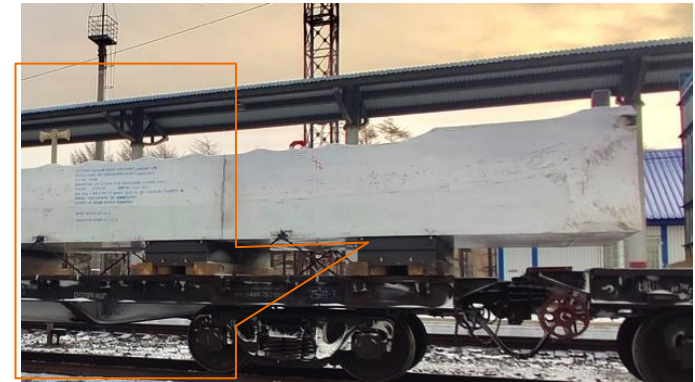
Tube bundle #102 support #1 prior to discharge

Visual inspection results: 3 of 4 tube bundles have cracks in the support #1 and C-Chanel bends in other supports

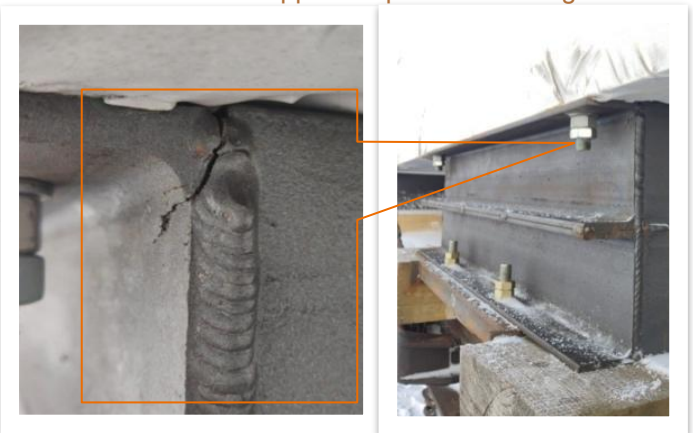
Tube bundle #93 support #1 damage

Kerry have visually inspected part of the support beam and found cracks in the transport frame beams (as shown in the pictures).
