## Lift up hole RF breakdown

### SE-4000 Experimental

2006.06.27 ~ 2006.07.14    Old type cathode block was checked  
by high RF voltage bias (up to 8200

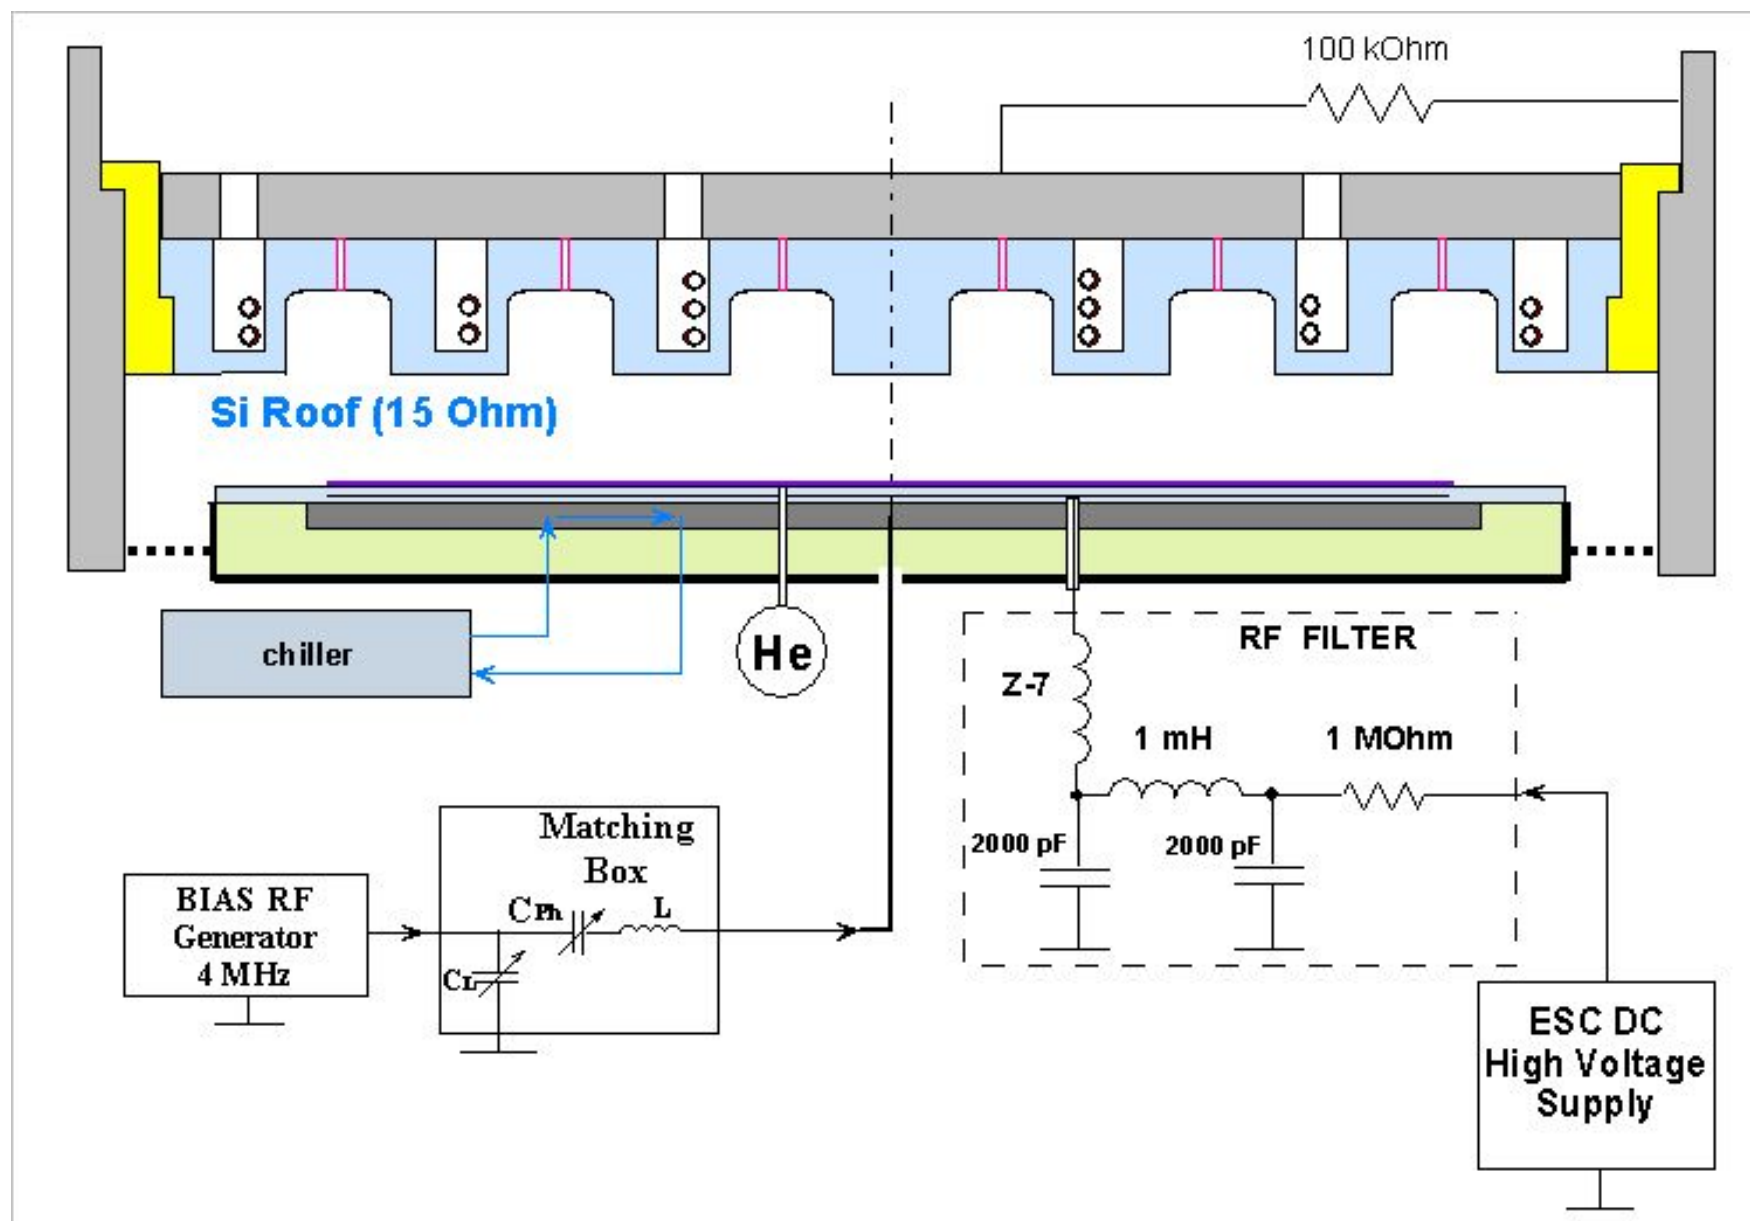
Standard connection was used in this experiments:  
RF power - to base electrode,  
DC high voltage – to ESC was applied.

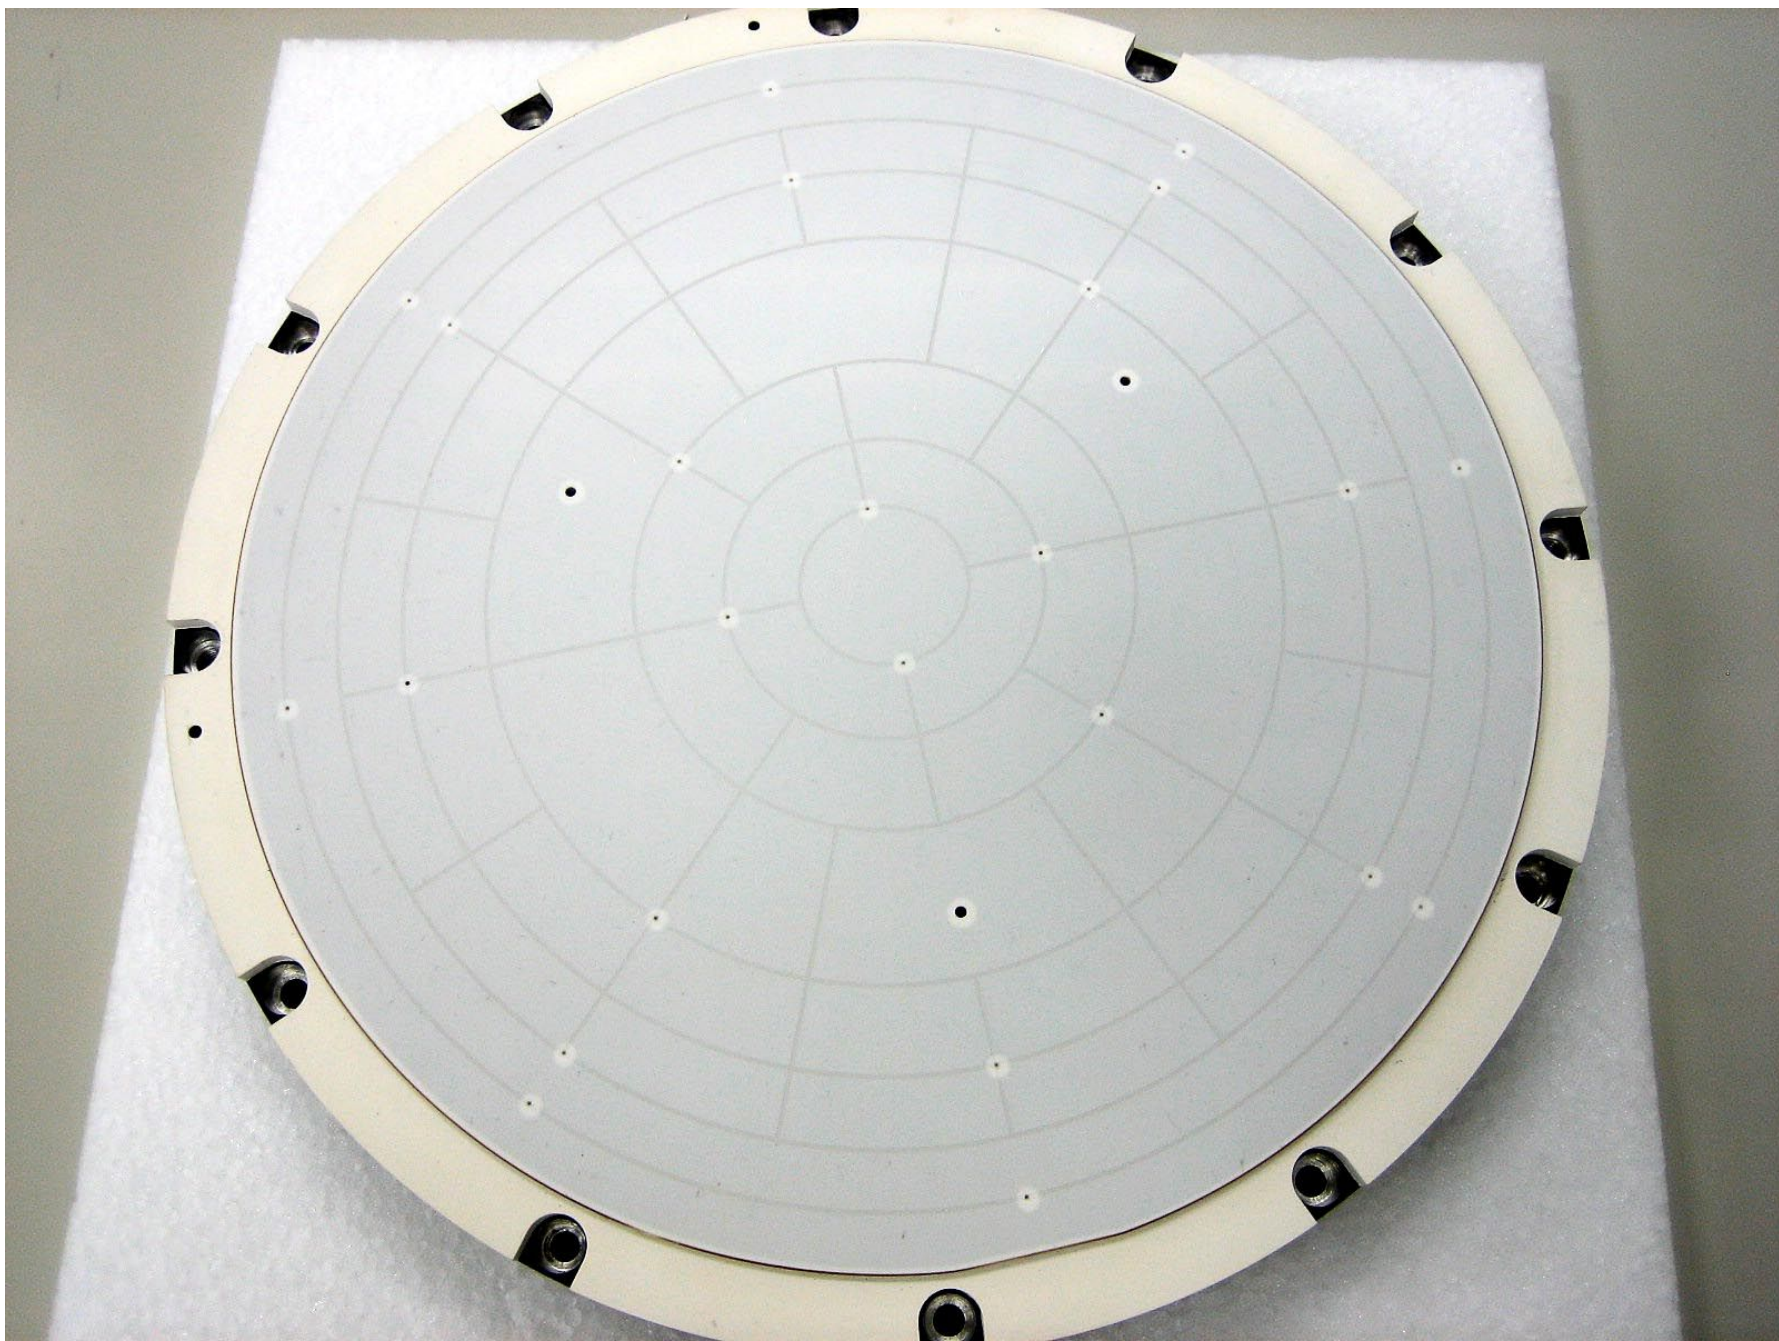
After experiment ESC surface has no damage, although many gas hole low power breakdowns occurred

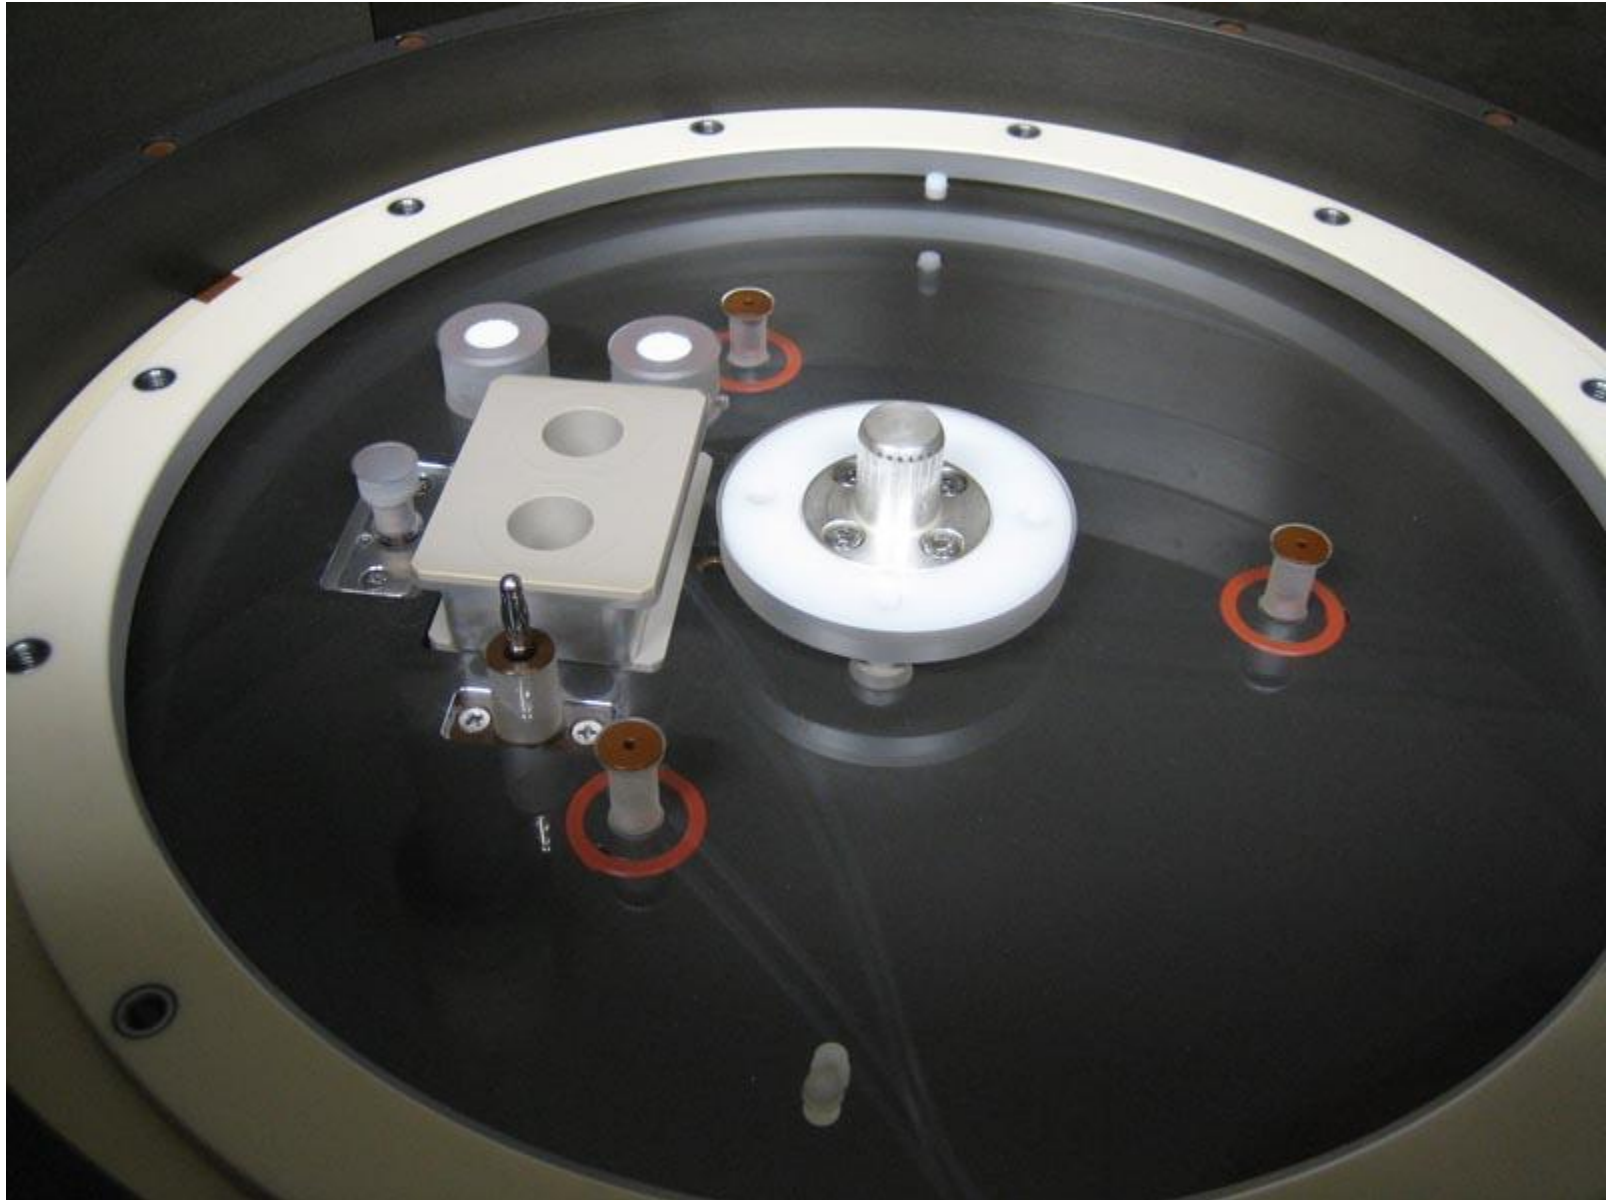
Under cathode parts has no damage too.

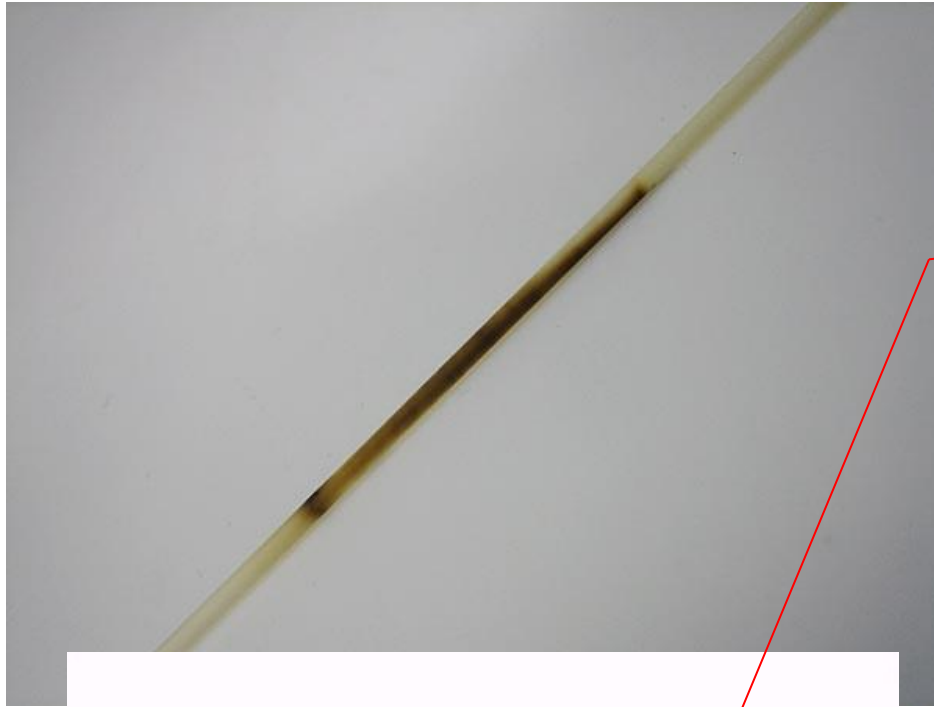
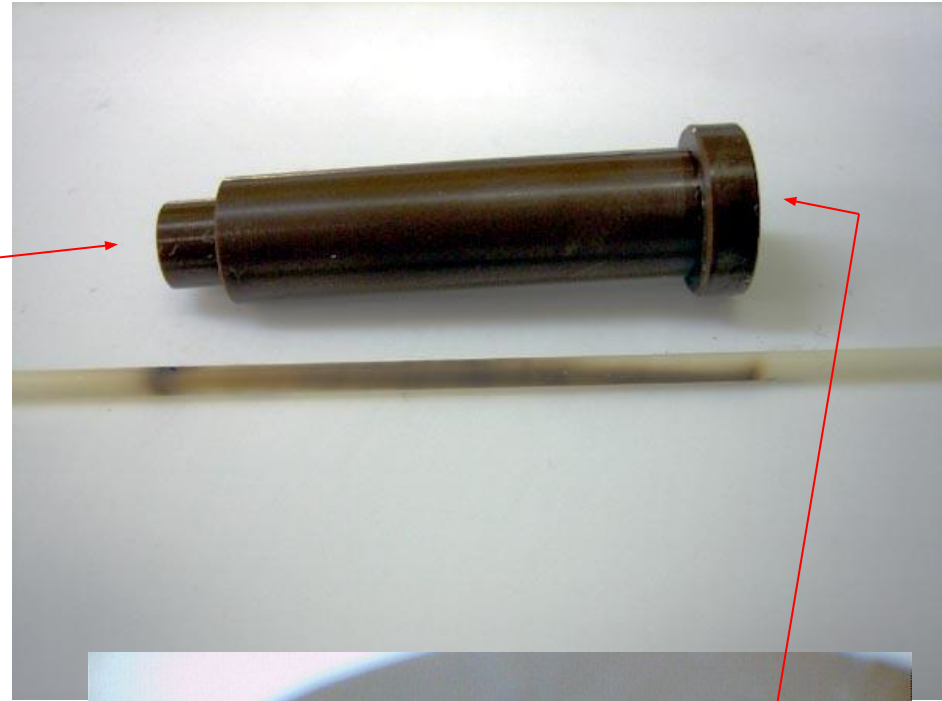
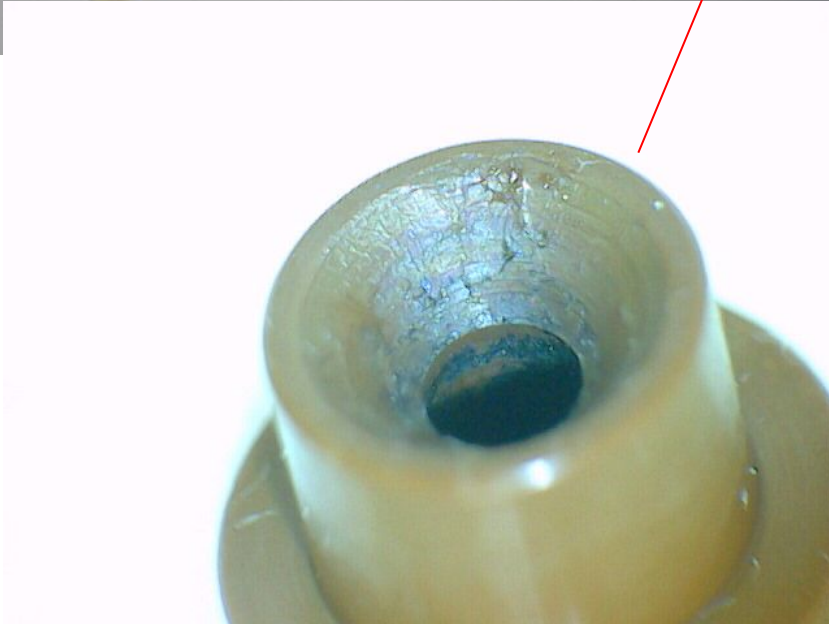
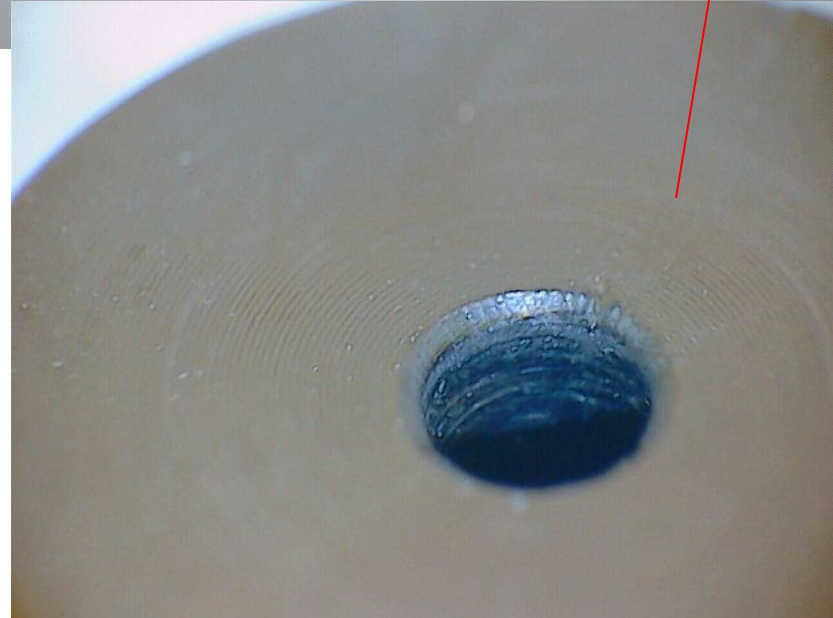
But one lift up hole and lift up pin has traces  
of RF capacitive discharge

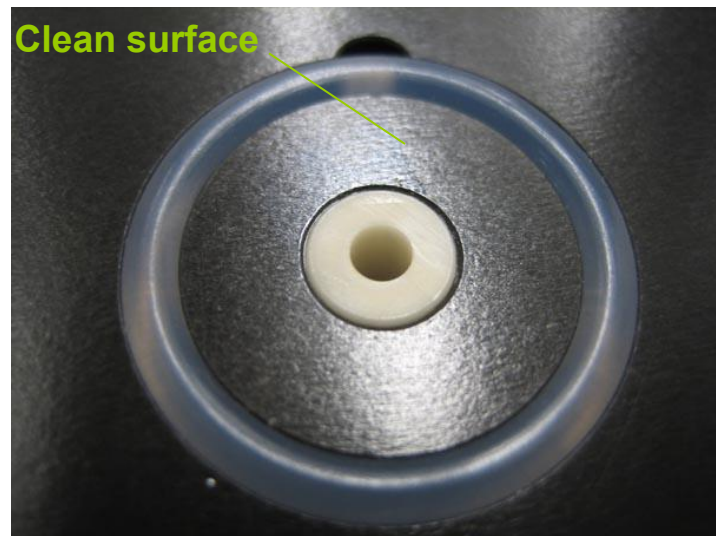
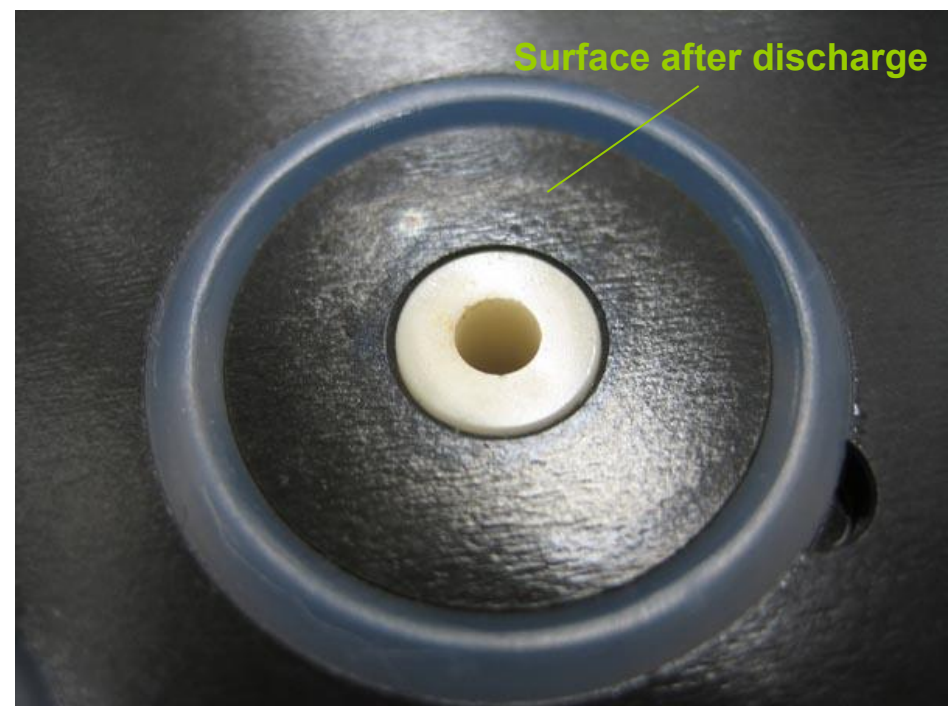
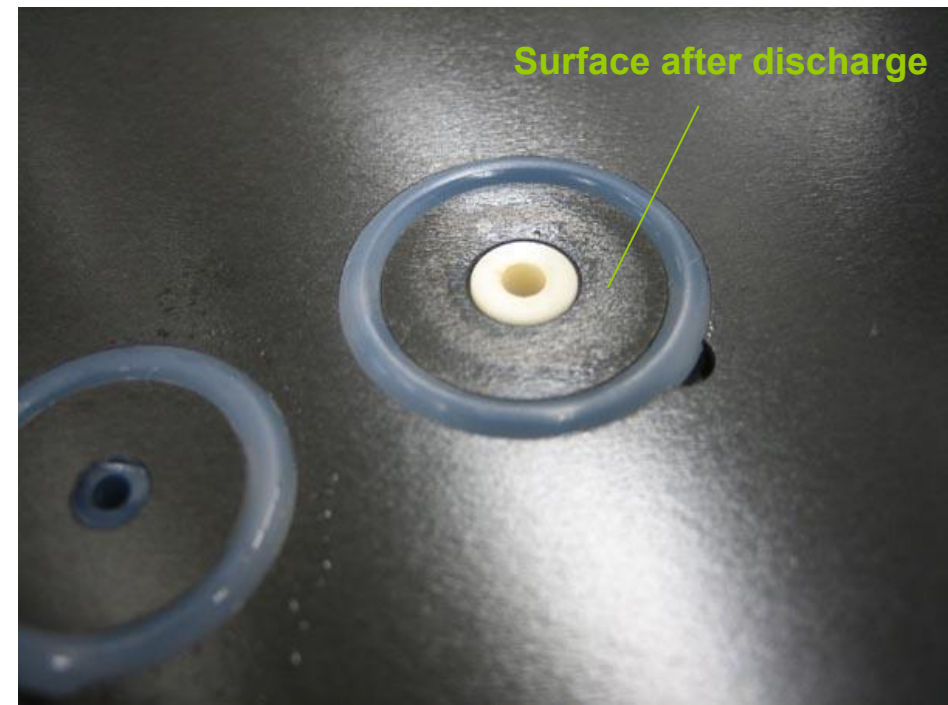
Cathode bottom surface around this lift up hole has traces of RF capacitive discharge too.

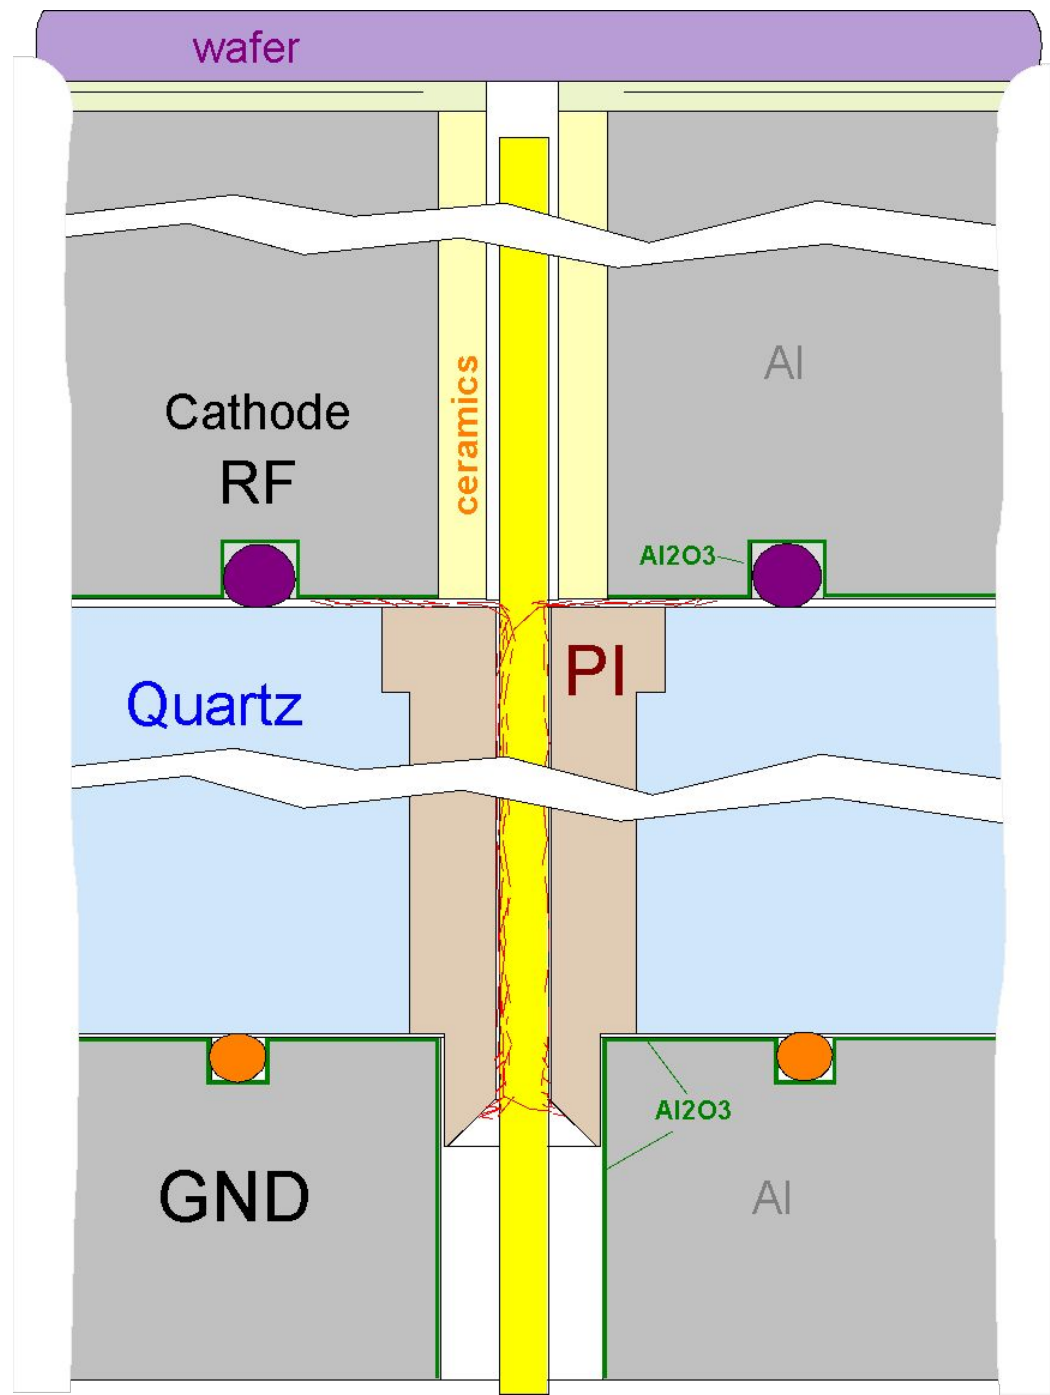
Position of capacitive discharge  
inside lift up hole
