HSE Networking 2016 Heidenheim April 26th-28th BDI, Russia, Domodedovo

Ekaterina Merkulova April 2016

In BDI was 2 accidents in 2015

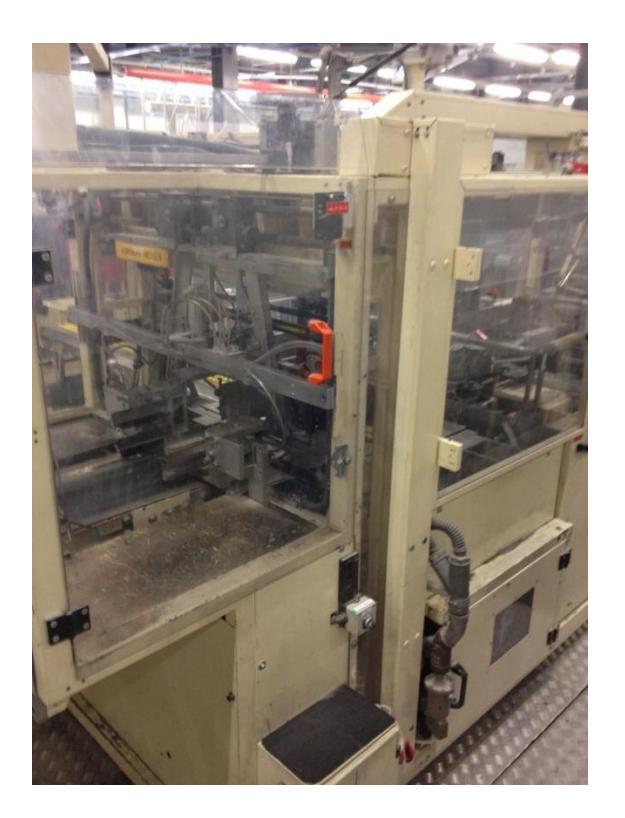
Date: 16.12.2015

Place: on KU#8 line (PSM, bag packing machine)

Type of injured: incised wound of the right hand

Circumstances:

In the night shift at around 1:15 the operator on the KU#8 line operator was doing an adjustment of commissure of packets with pads, namely, the direction of flow of compressed air. When he was doing an adjustment of the direction of flow of compressed air, the welding bar, put down and cut right wrist of the operator (around 2 sm in length and 1 sm in depth). Before starting this activity,

the operator did not stop PCM machine and did not checked the end switch. The end switch was not reliably fasten on protection door, when the accident happened.

Basic cause:

• The end switch was broken. The end switch was not fastened on protection door.

Another causes:

- lack of safety discipline on the shop floor level
- violation of the safety requirements by operator
- low control for technical safety equipments

Corrective measures:

- The end switchs was fasten on protection door and checked another end switchs on lines. (This was done immediately after accident.)
- All end switchs was fasten reliably, with out opportunities to take off it easy with simple equipment (e.g. screwdriver).
- All employees of production department were instructed
- Process and procedures of tecnical maintenance was reviewed and improved
