New 700er Light shaft

Load and installation

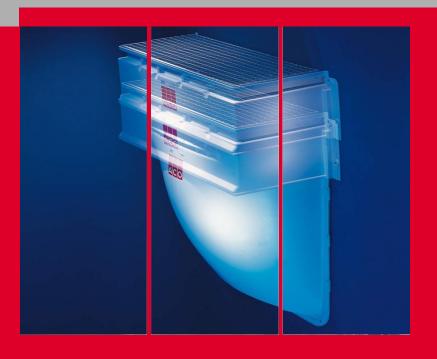
Load during the installation

- ❖Light shaft installed 2 screws
- Grating is in the correct position
- Fill the Excavation in layers with gravel
- ❖Compression pressure 2.000 kg

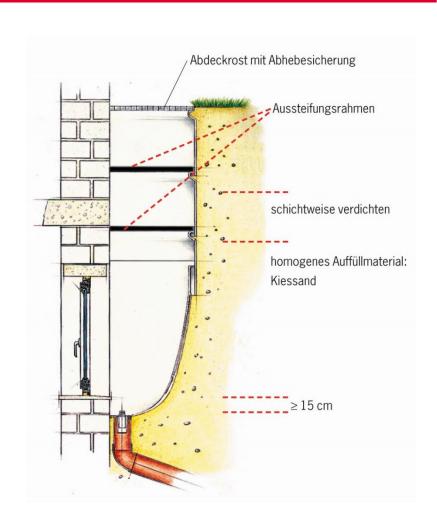
Load: walk able

Test:

⇒ Load 200kg in the middle of the grating on a test block 200x200mm

These is the first FEA Test.

Light shaft installed but no gravel around

Grating in position

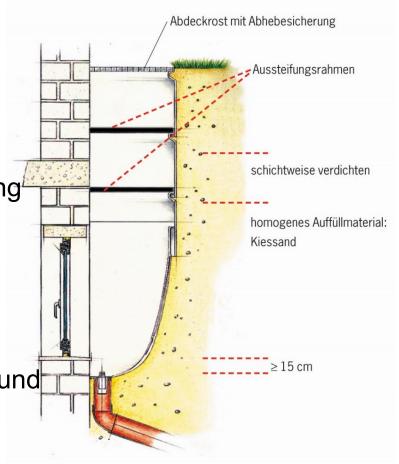
Load: water load

Test:

⇒ Load: water level 540mm above grate support, messure the deflection with the water load after 5min, 1 hour, 12 hours and 24 hours.

These is the second FEA Test.

⇒ on the photo you see only the light shaft without extension elements

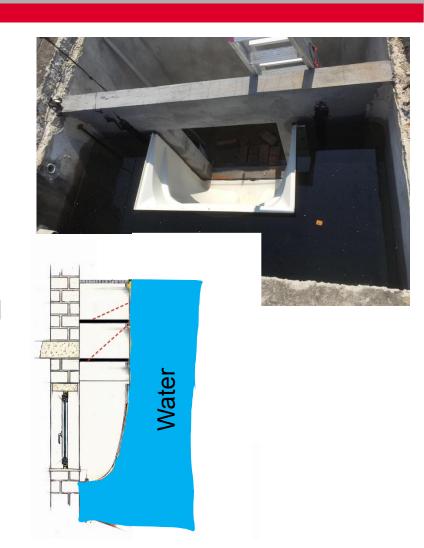
Load: water load

Test:

- Light shaft installed in a concrete basin but no gravel around, 2 fix extension elements installed water tight.
- ❖No grating
- ❖Lightshaft in front of an opening that it is possible to messure the deflection.

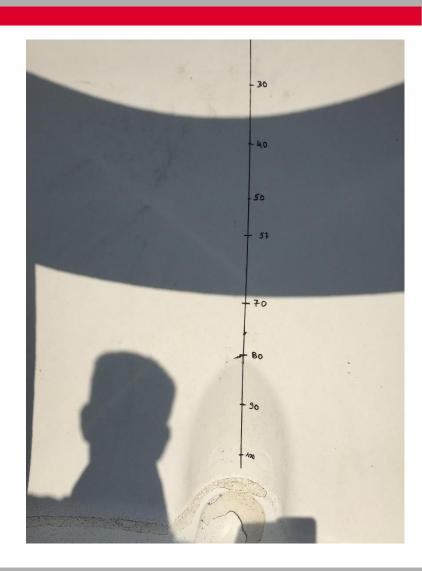
Load: drive able

Test 1:

- ⇒ Load 1000kg in the middle of the grating on a test block 200x200mm
- Light shaft installed but no gravel around
- Grating (drive able) in position

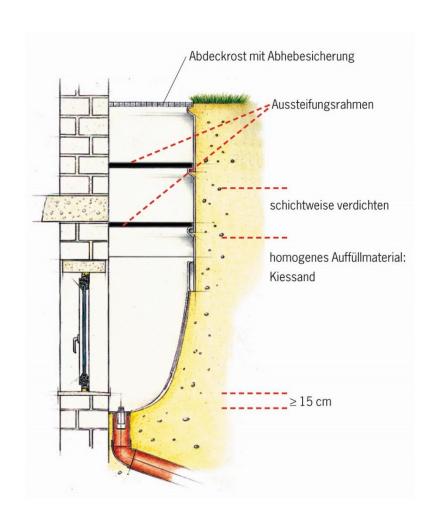
Load: drive able

Test 2:

- ⇒ Load 1000kg in the middle of the grating on a test block 200x200mm
- Light shaft installed with gravel around
- ❖Grating (drive able) in position

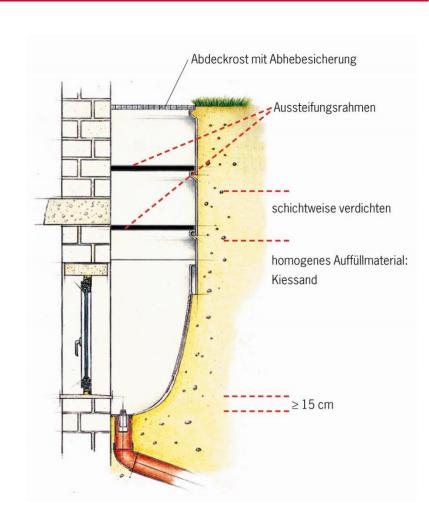
Load: drive able

Test 2:

- ⇒ Load 900kg just beside the grating in the middle of the light shaft on a test block 200x200mm
- Light shaft installed with gravel around
- ❖Grating (drive able) in position
