We offer you to get acquainted with the list of equipment offered by LLC Promtekhkomplekt to solve the voiced problems in oil production

**Equipment for well stock, complexed by corrosion and asphalt, resin and paraffin deposits:
Fiberglass sucker-rod**

Fiberglass oilwell tubing and casing string pipes

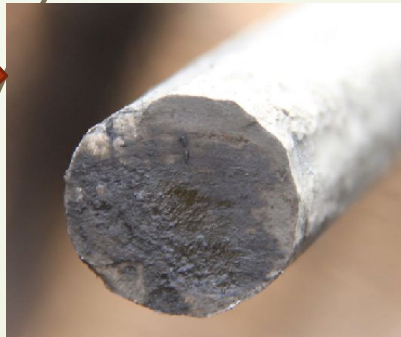
corrosion damage of metal rods

With every coming year an issue of downhole equipment durability hits up oil and gas producing industry. Corrosion failure of the metal turns to be the main problem, which leads to break-and-shutdown of the well.

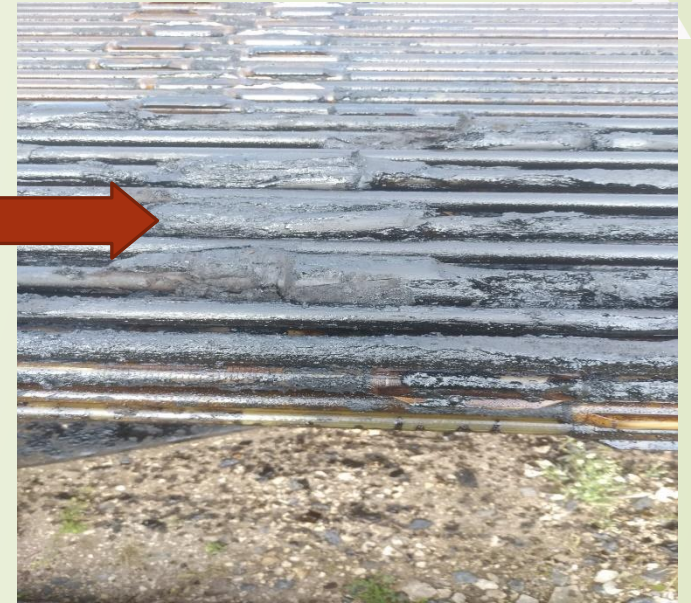
paraffin deposits on metal rods

Except for corrosion failure of the metal, there are salts and paraffin depositions – also leading to the well shutdown.

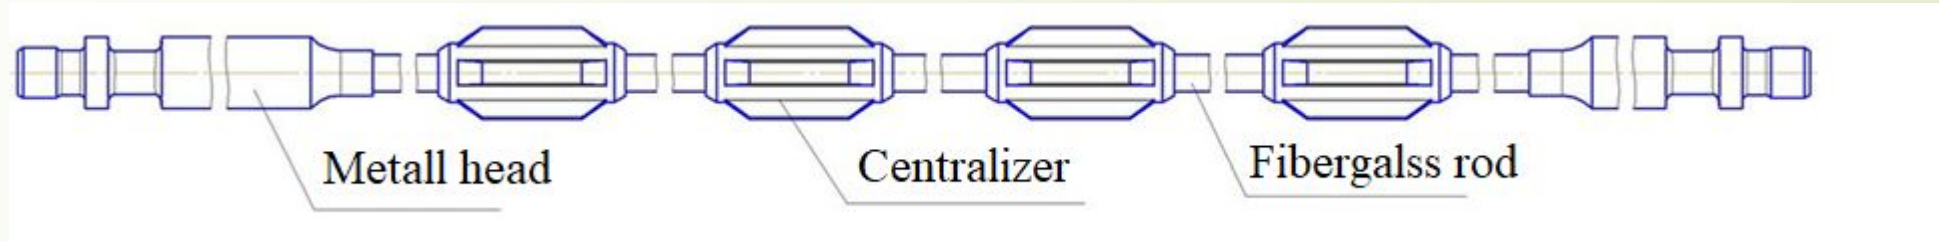
Construction. General characteristics.

Sucker rod type	Mass, kg	Guarantee time, month	Resource, mln. cycl.	Chance of failure-free performance	Length, m.
Fiberglass sucker rod pump FSR25-8000-D-2	11	24	7,5	0,999	to 15
Steel sucker rod	33	6 (12)	5 (7,5)	0,996	to 9,2

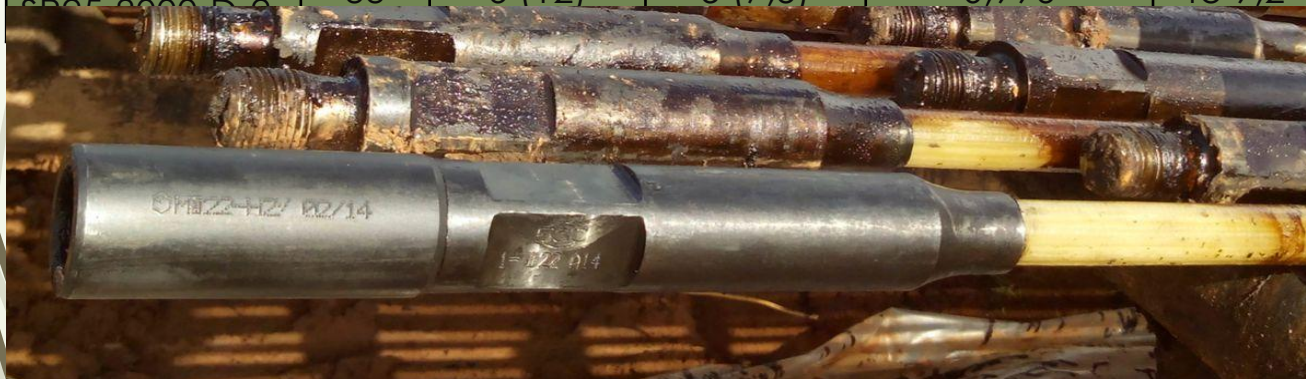
The photograph shows several sucker rods stacked together. In the foreground, a fiberglass rod is visible, connected to a metal head. The metal head has some markings, including "01122-112/ 02/14". The rods are arranged in a way that shows their different materials and components.

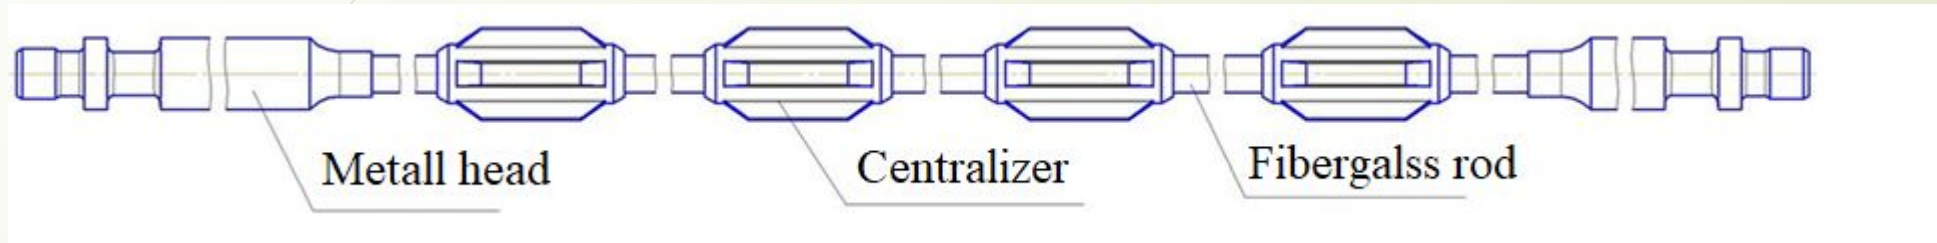
The design of the fiberglass pumping rod produced by LLC UK Promtekhkomplekt and the world leaders Weatherford and John Crane is visually similar.

However, due to the improvement of the internal structure of the joint, it was possible to achieve an increase in technical indicators for the maximum load on the rod and the working load, as well as significantly reduce the cost of the rod.

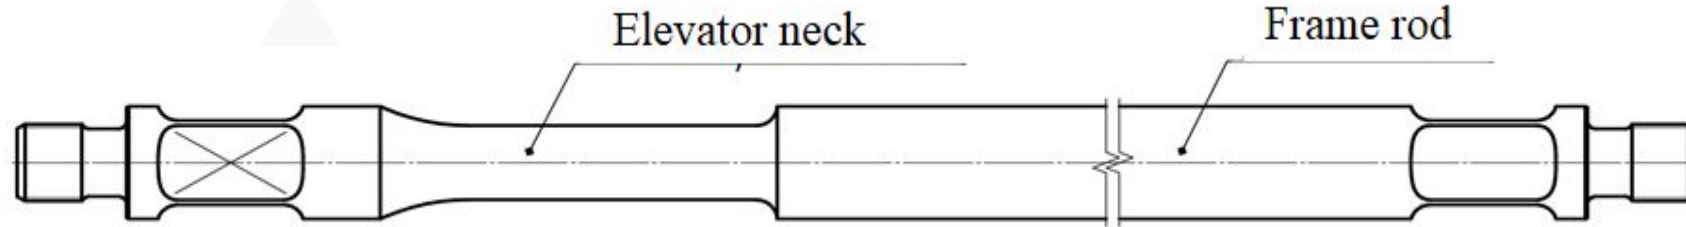
Weighted modified pump rod usage

Weighted rod	Mass, kg	Elevating neck diameter, mm	Fishing neck diameter, mm	Thread	Final size, mm	Roughness, mkm
WMPR44-6100 (ТУ)	71,6	29	-	22	33	Ra 1,25
WPR44-6100 (ГОСТ)	71,2	25	25	22	38,1	no machining

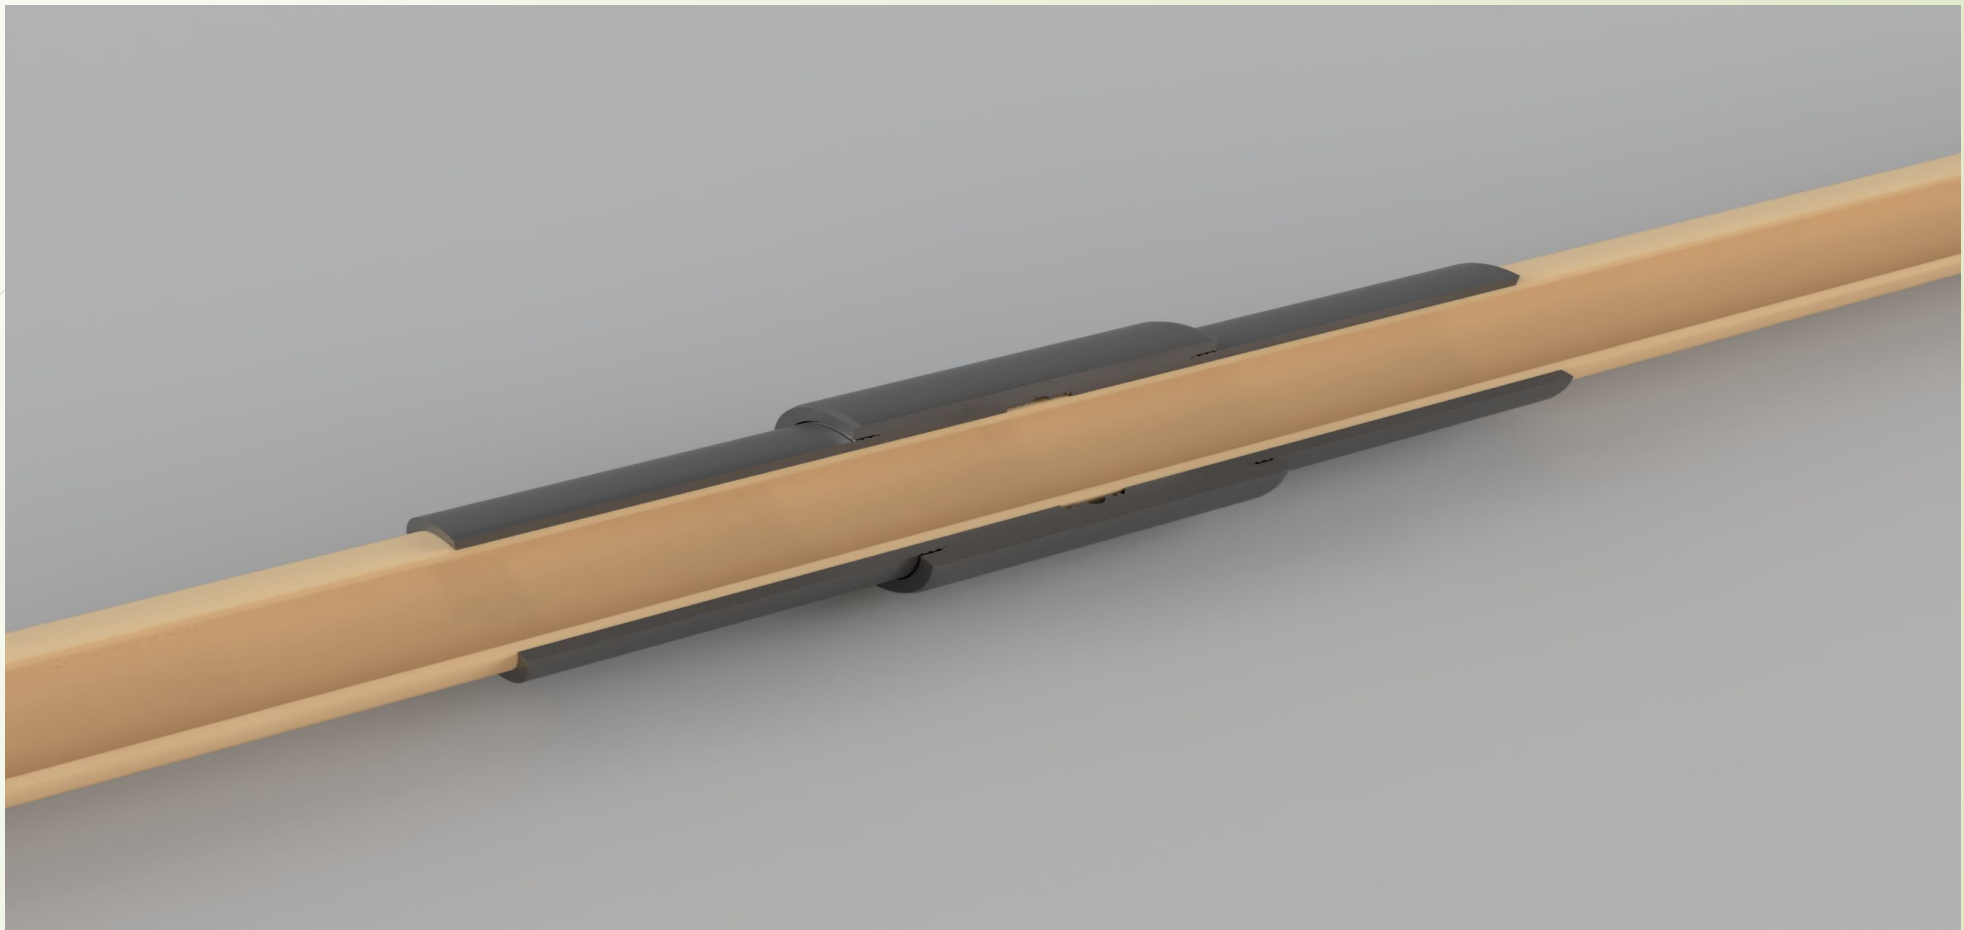
The patented non-separable connection of fiberglass and metal allows for the complete absence of liquid-metal contact, and the perceived axial loads correspond to the strength groups C90, T95, P110.

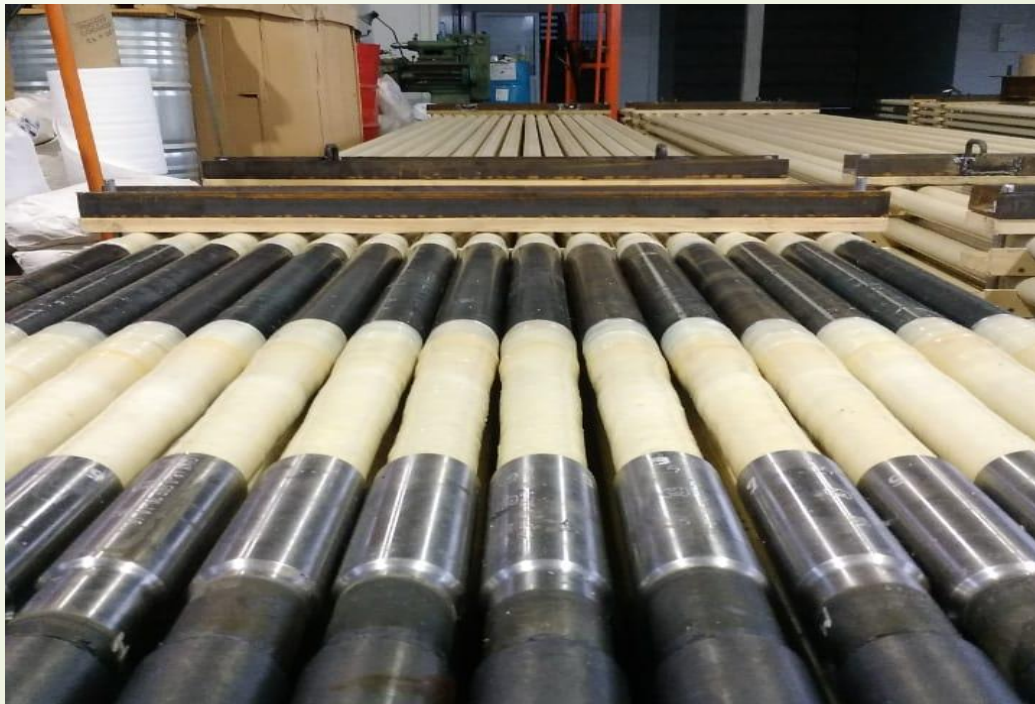
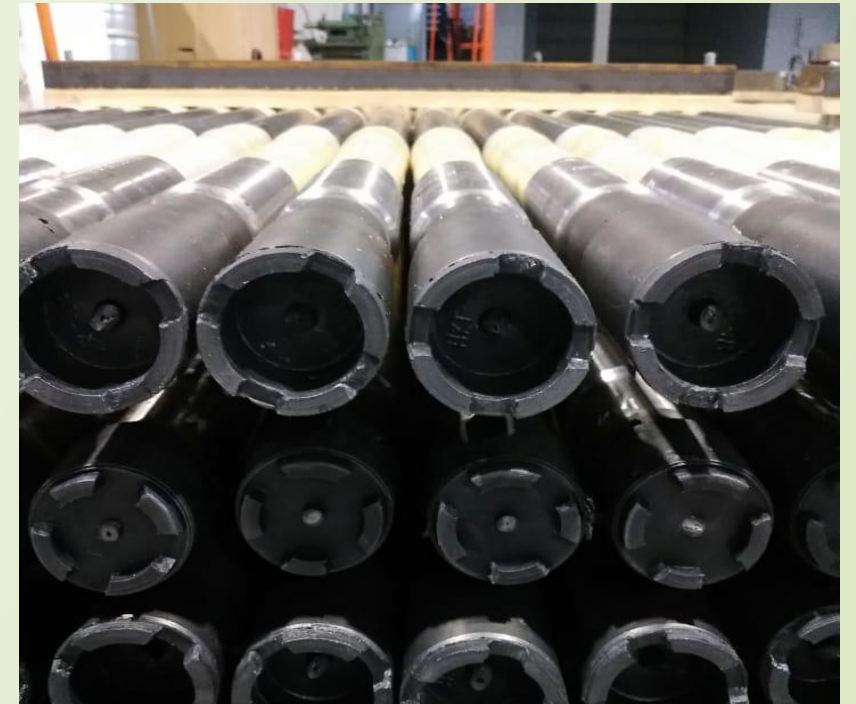
Technology of repair/remanufacturing of FOT presumes removal of used screw joint, removal of fiberglass pipe body defective areas, and paste-in of metallic caps with screw joint according to GOST 633-80, 31446-2017

On the analogy of new FOT production process, there has been developed new technology of repair/remanufacturing of currently existing on the market fiberglass oilwell tubing, made by LLC "FPP" and LLC "FiberGlassRus". Conception of repair/remanufactured FOT is approved on customer preference.

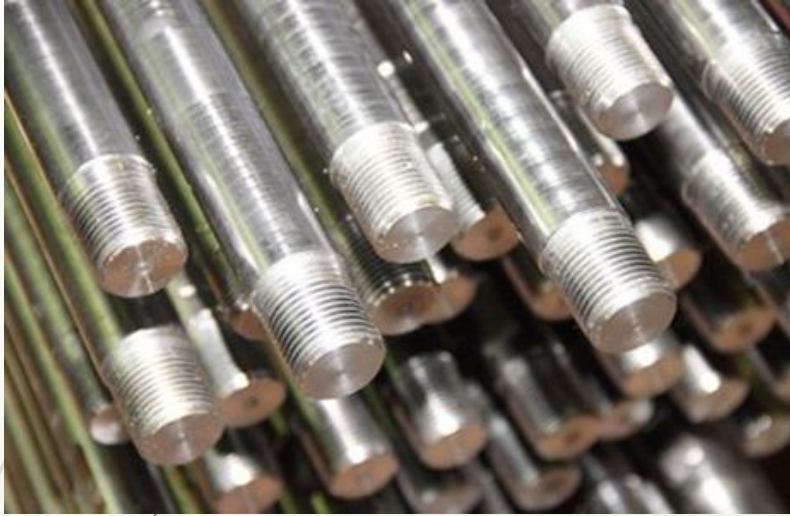
- We produce standard wellhead rods and modified with special properties;
- Corrosion-resistant design for use in aggressive environments;
- High surface hardness to reduce erosion wear;

Technical specifications:
Standard sizes of rods: 28, 32, 38 mm
Rod lengths: up to 12,000 mm.
Strength classes: C, K, D.
Steel grades: ASTM 1045, 5140, 4130,
4140 and special anti-corrosion steel.

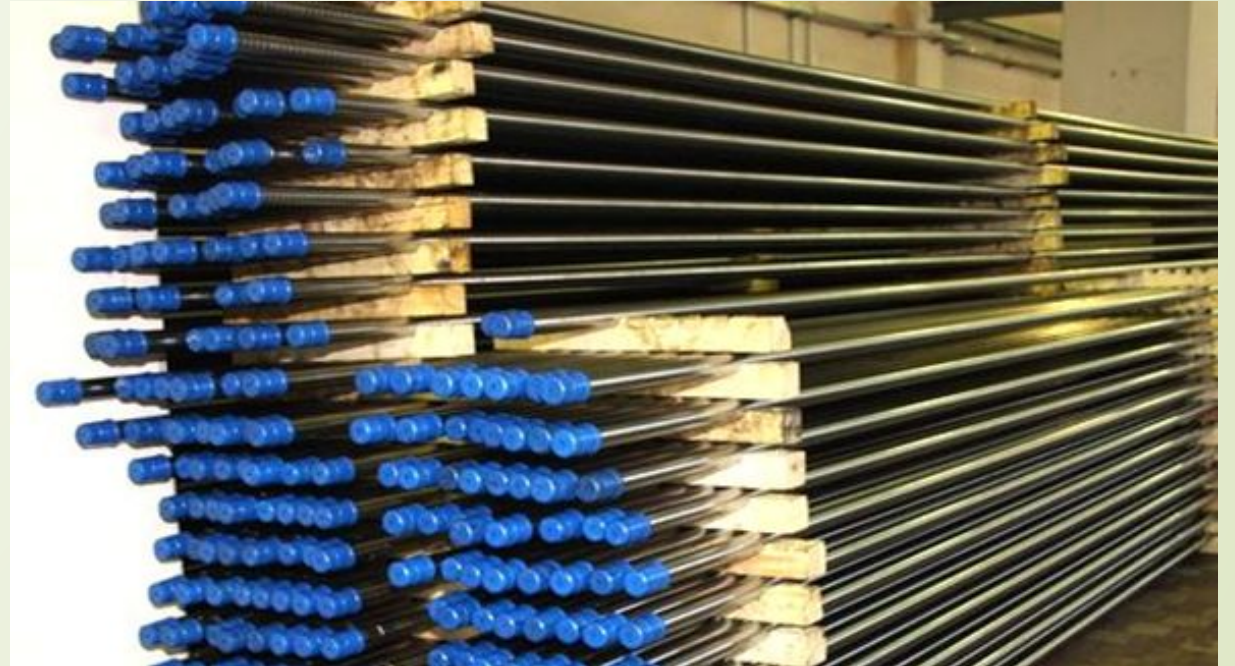
Another development of the technology of connecting metal with fiberglass was the creation of filters for deep rod pumps and pipes.

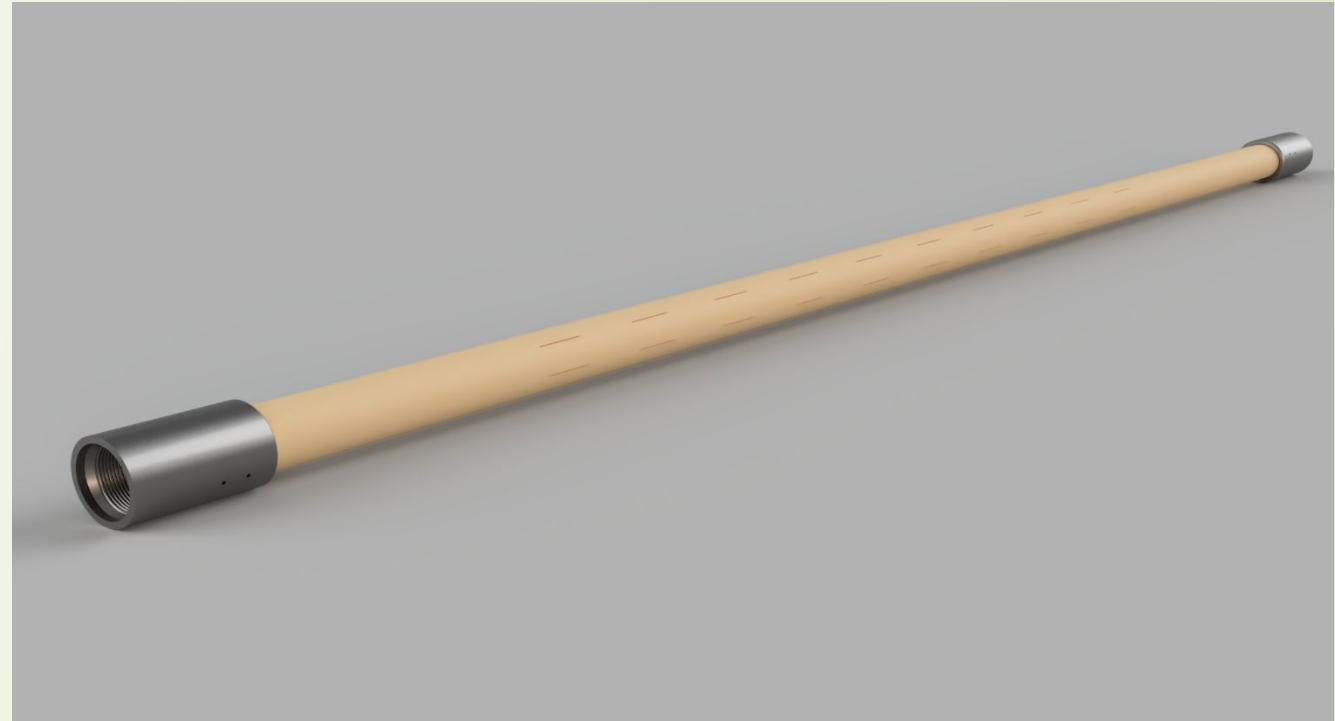
For fiberglass pipes, the operating time for 2 years showed a minimum content of paraffin deposits on the walls, which does not reduce the efficiency and throughput. increases the time to failure.

As a result of the introduction of fiberglass filters in the company of PJSC "Rosneft", this technology was included in the list of recommended applications and is actively used in the configuration of rod pumps.
