Coils deformation
Wire rod mill - Ostrava

Team 3: Dmitriy, Marek, Mateusz, Jacek, Karine.

How can we decrease the occurrence of physical deformation of wire coils during collection and binding?

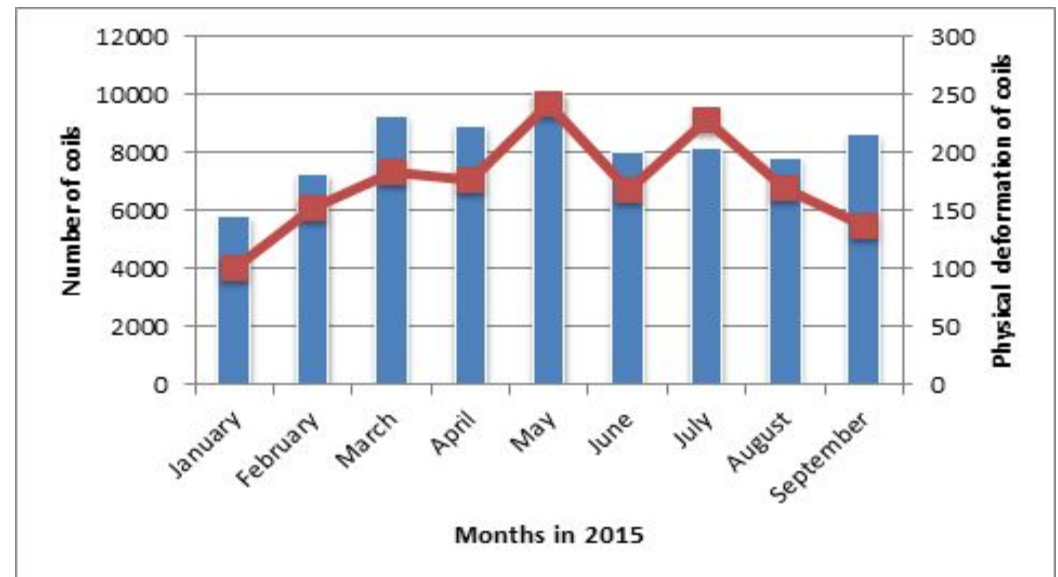
- In 2015, 2.1 % of the total production is affected by this quality defect. Analysis per criteria not done (data per line, steel grade, ... not available);
- Mostly, the inner part of the coil is affected. No specific position identified (data not available);
- The problem is expected to occur during collection of the wire (gap between bell and thorn). Problem is random, no frequency linked with particular event (ie maintenance event).

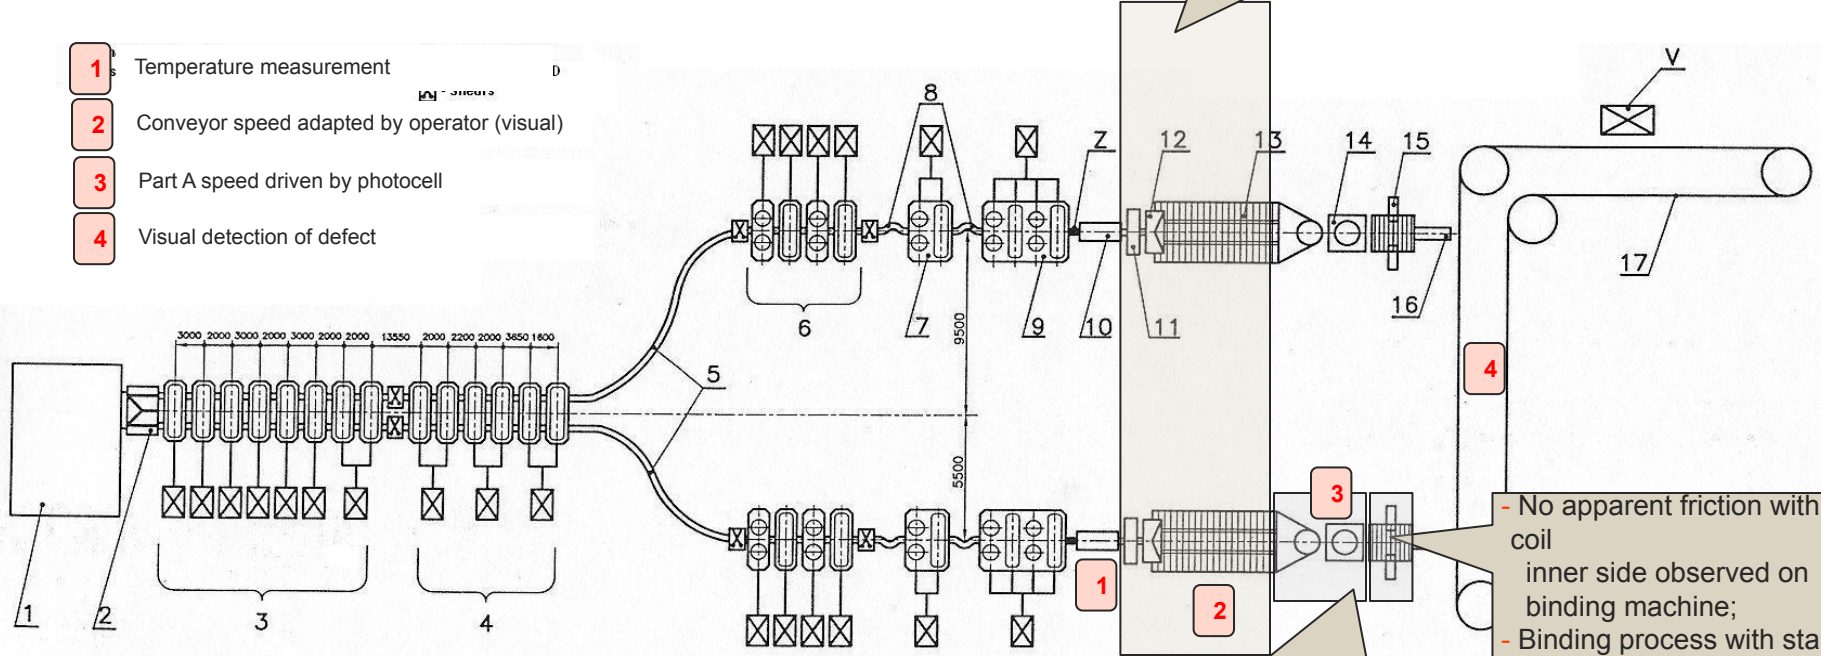
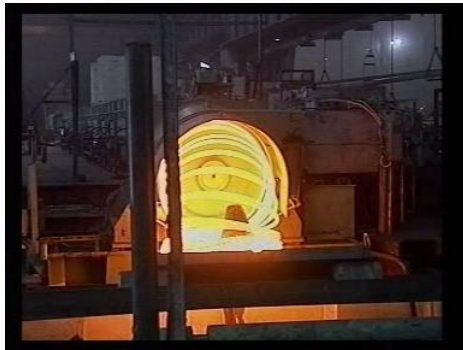
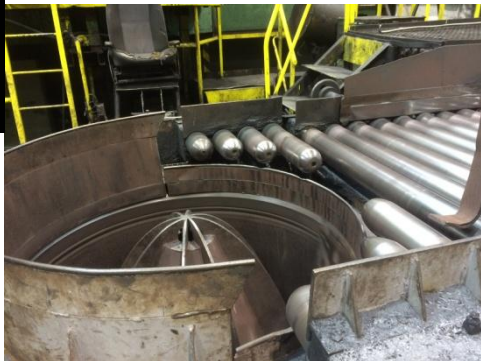
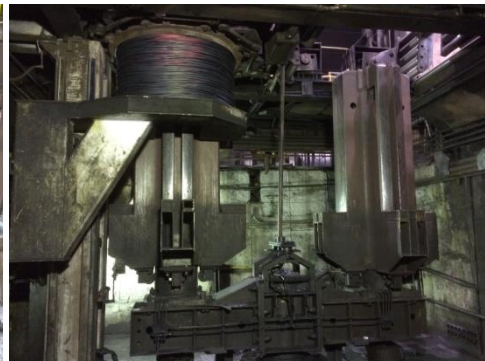
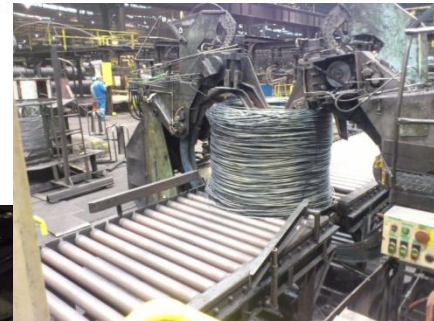
DIAGNOSE / Go & See

- 1 Temperature measurement
- 2 Conveyor speed adapted by operator (visual)
- 3 Part A speed driven by photocell
- 4 Visual detection of defect

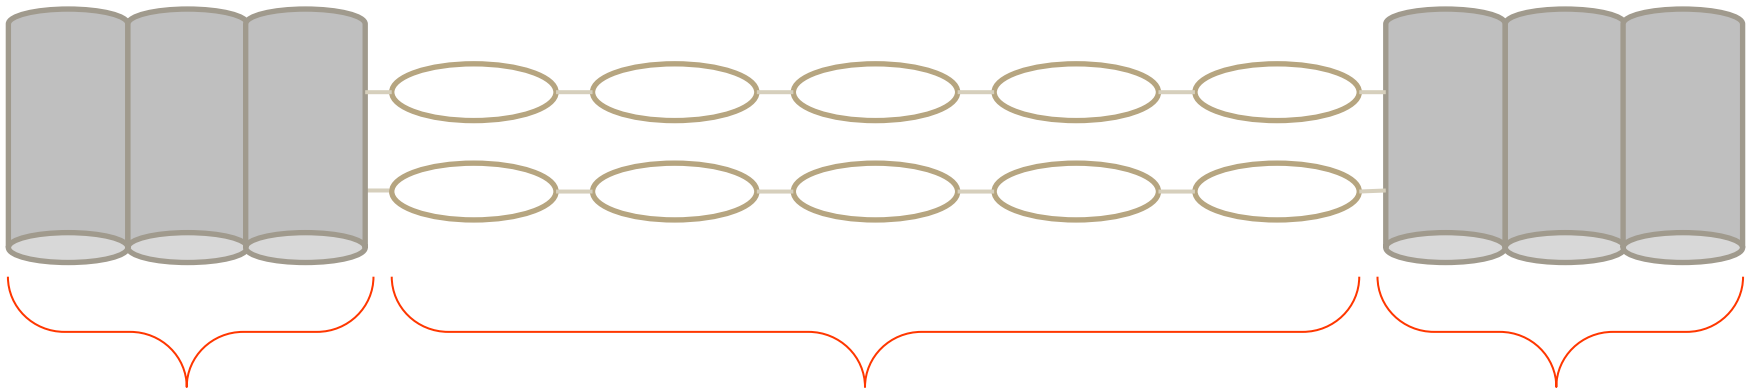
Design\Cooling bed.

Cooling bed consists of rollers (the first and the last sections) and chain (in the middle) section.

Speed of all f these parts aren't synchronized between each other, what can the problems with formation of separated coils.

Speed of all f these parts must be synchronized between each other for eliminating of stretching or regaining speed of bunch.

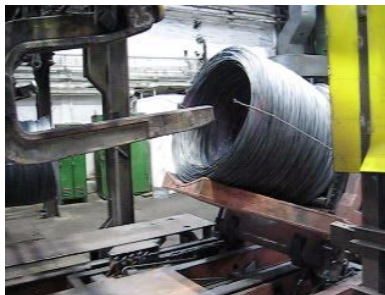
<p>Bundle of wire is transported to the hook under some angle.</p>	<p>Bundle of wire must be transported under the straight angle, for avoiding its movements.</p>
