# Root Cause Analysis (Tube Bundle)

# Tube Bundles Progress Report

# Transshipment operations in Nogliki & Damage Report

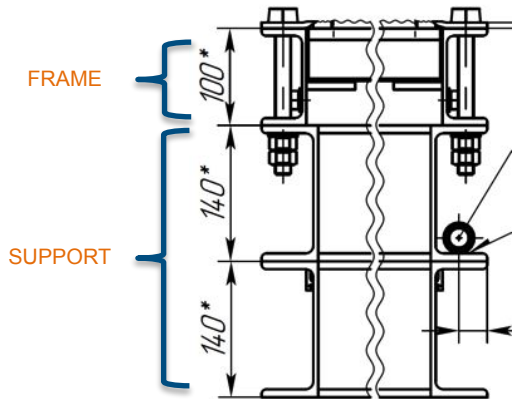
- Missing transversal beams No. 1 and 5 in frame over the support beams and in the lashing points to distribute the weight.
- No 100% overlap: C-Chanel frame shorter than C-Chanel of support

No transversal beams over supports to distribute the weight

No 100% overlap: C-Chanel frame shorter than C-Chanel of support

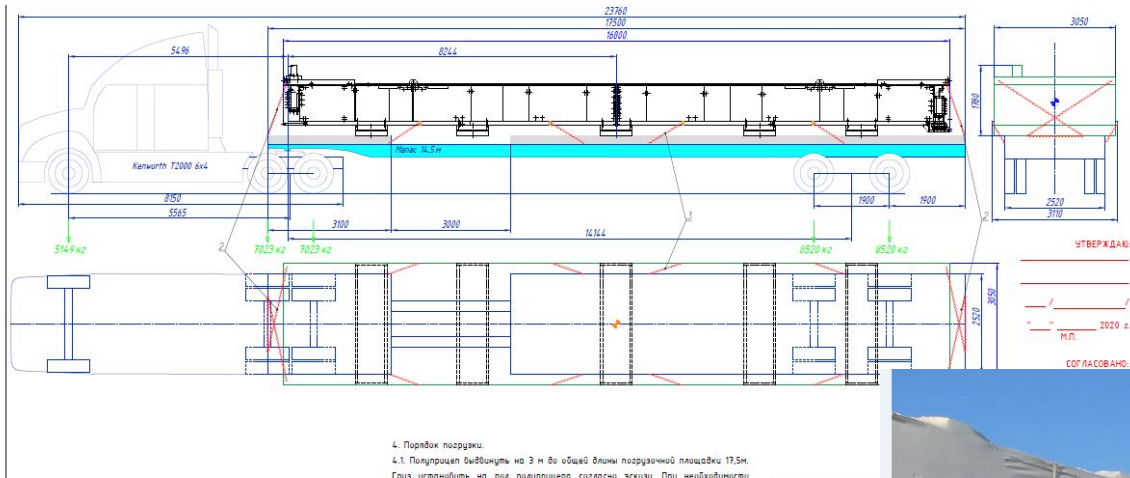
Transshipment of Tube Bundle No.93 onto extendable Trailer. Scheme Below

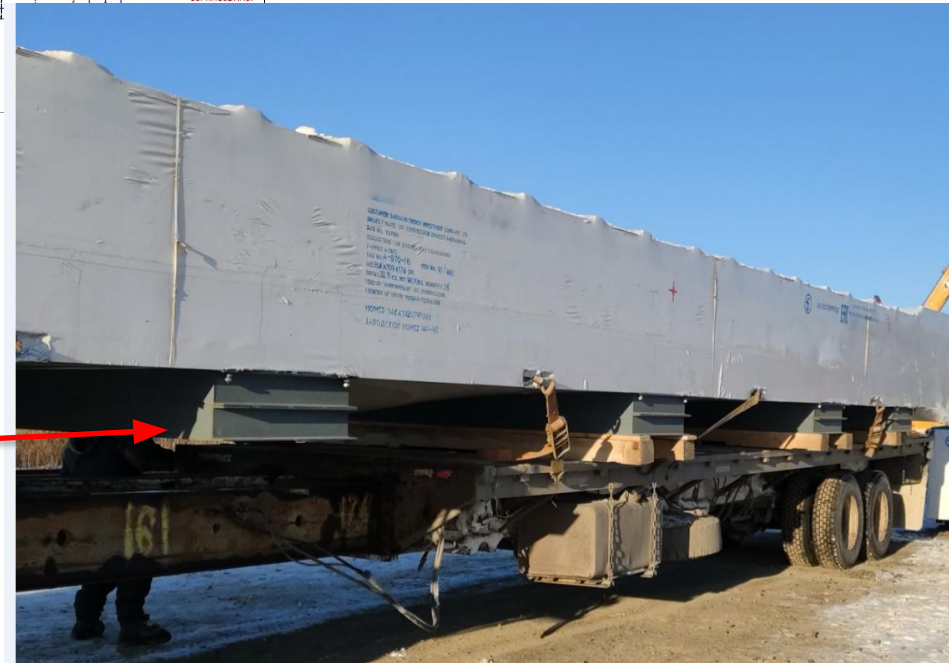
Photo

It demonstrated on road scheme 4 support beams are acceptable to proceed road transportation. In accordance with comments made the final scheme features 8 belts to protect the cargo against longitude movements.
