CCTV Headquarters, Beijing

A Structural Design Overview

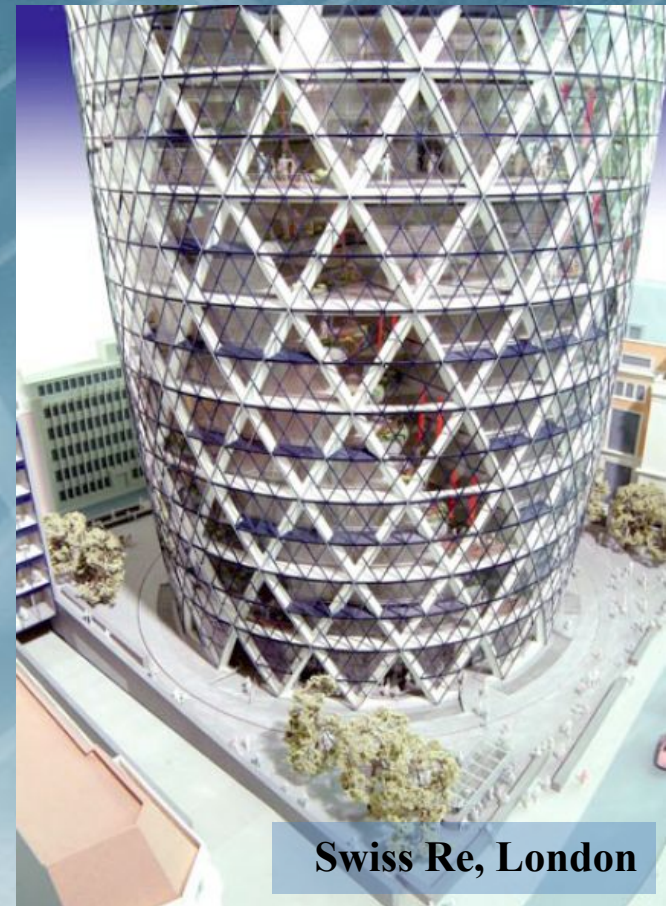
Swiss Re, London

- Short for *Diagonal Grid System*
- Triangulated structure with diagonal support beams
- Similar to a typical moment frame
- Triangles connected at *Nodes* and *Rings* intersect the nodes
- Combines the benefits of a hollow tube with a truss

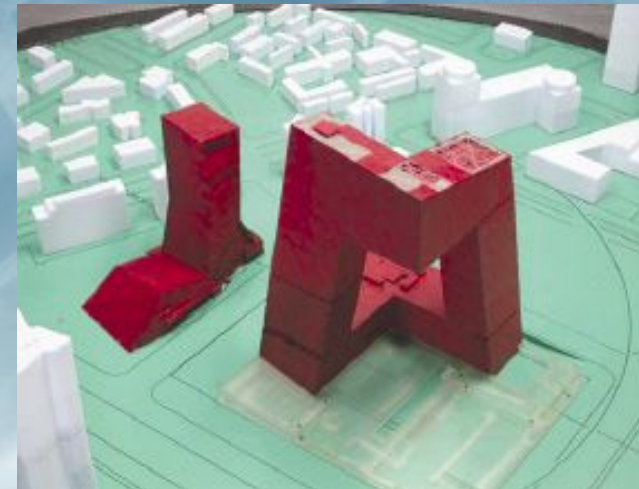
- Wind Tunnel Experiments had to be carried out to assess the severity of Wind Loads
- Building strength against a 100-year Wind was assessed
- Method: Dynamic Analysis using High-Frequency Pressure Integration Method
- 285 Pressure Taps installed on 1:500 Scale Model
- North and West Winds Critical
- Southwest Wind worst for Vertical Loads

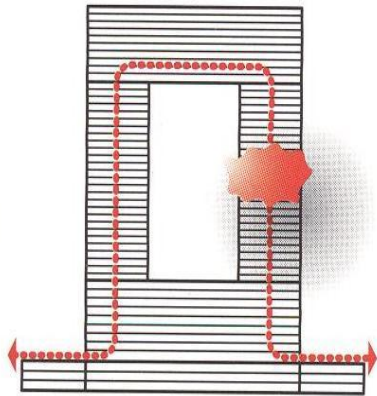
CCTV DIAGRAM

2 alternative exit directions

51min
stair exiting time

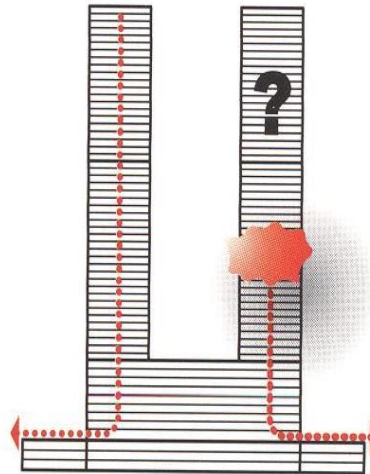
TWIN TOWER DIAGRAM

1 direction exit

73min
stair exiting time

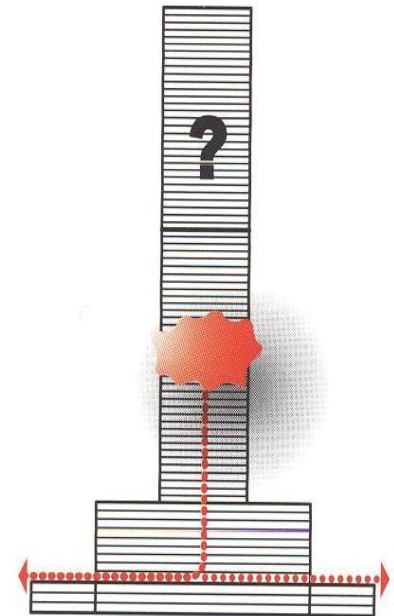
HIGH-RISE-DIAGRAM

1 direction exit

117min
stair exiting time
