RM2 - HOT CHARGING ELEVATOR ASSEMBLY

HOT CHARGING AREA OPERATIONS HAS BEEN SUSPENDED DUE, TO SAFETY REASONS AS HOT CHARGING AREA ELEVATOR CHAINS LINKS,PINS & CHAIN GUIDE BADLY DAMAGED.

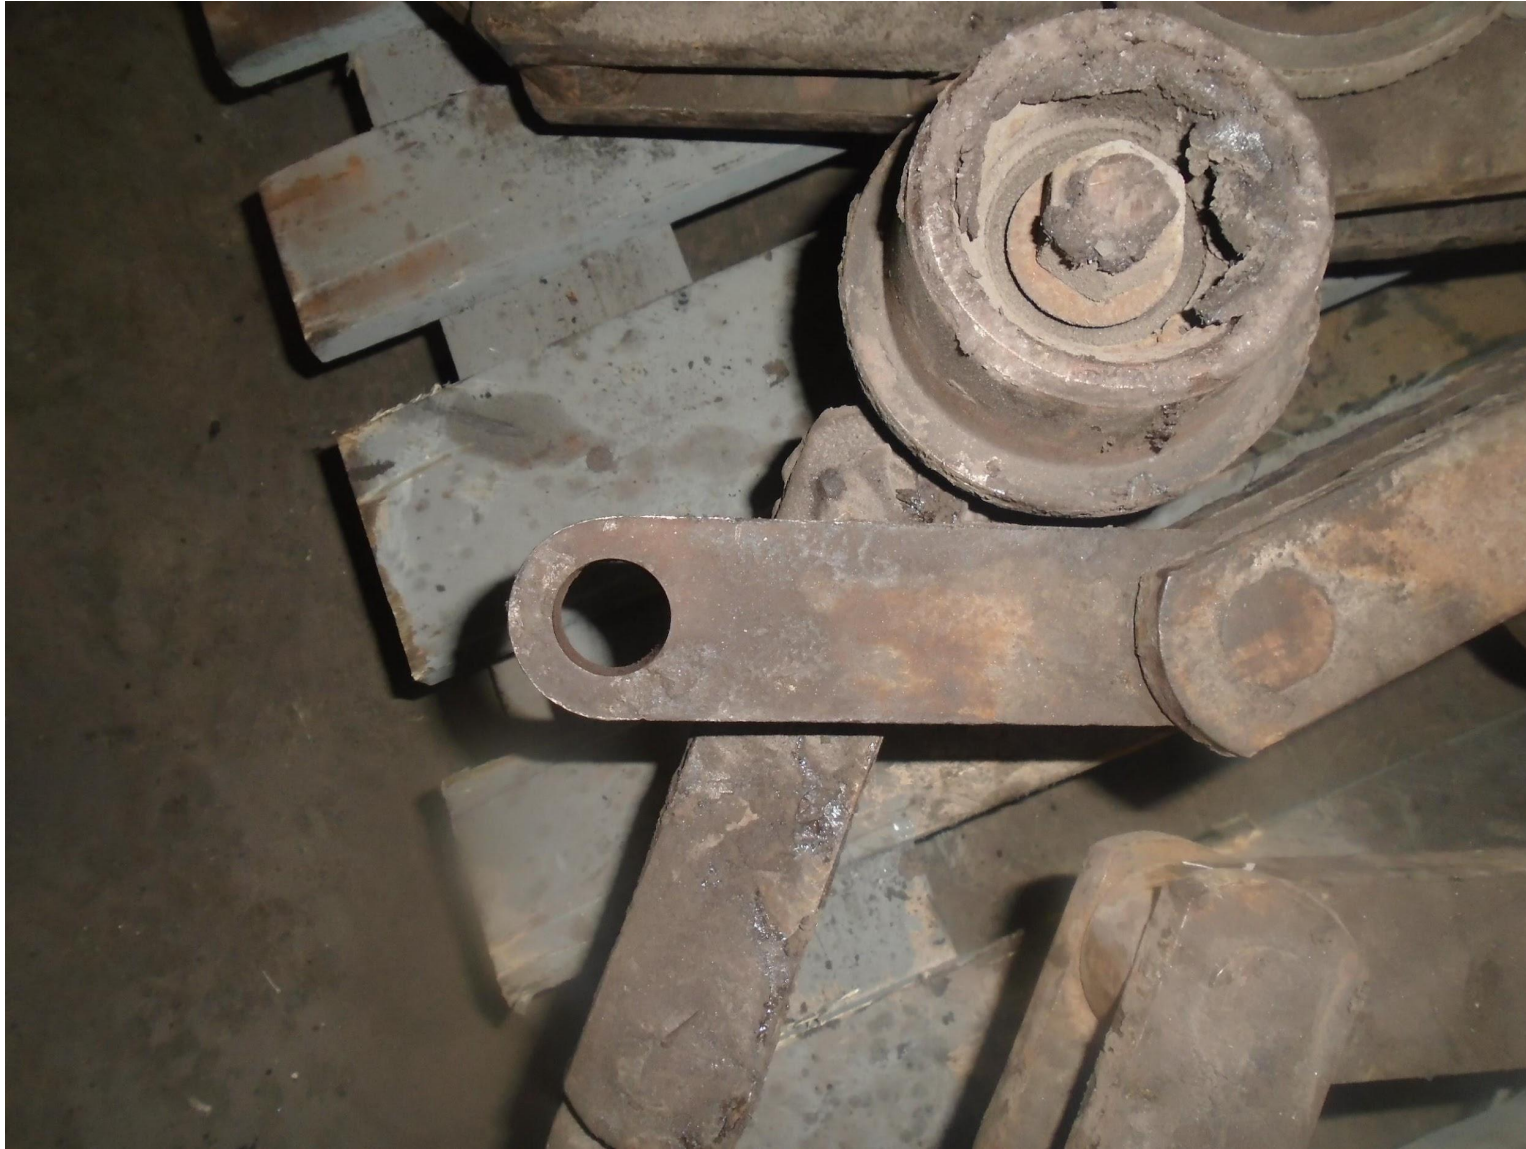
Elevator chain link's Pin hole worn out

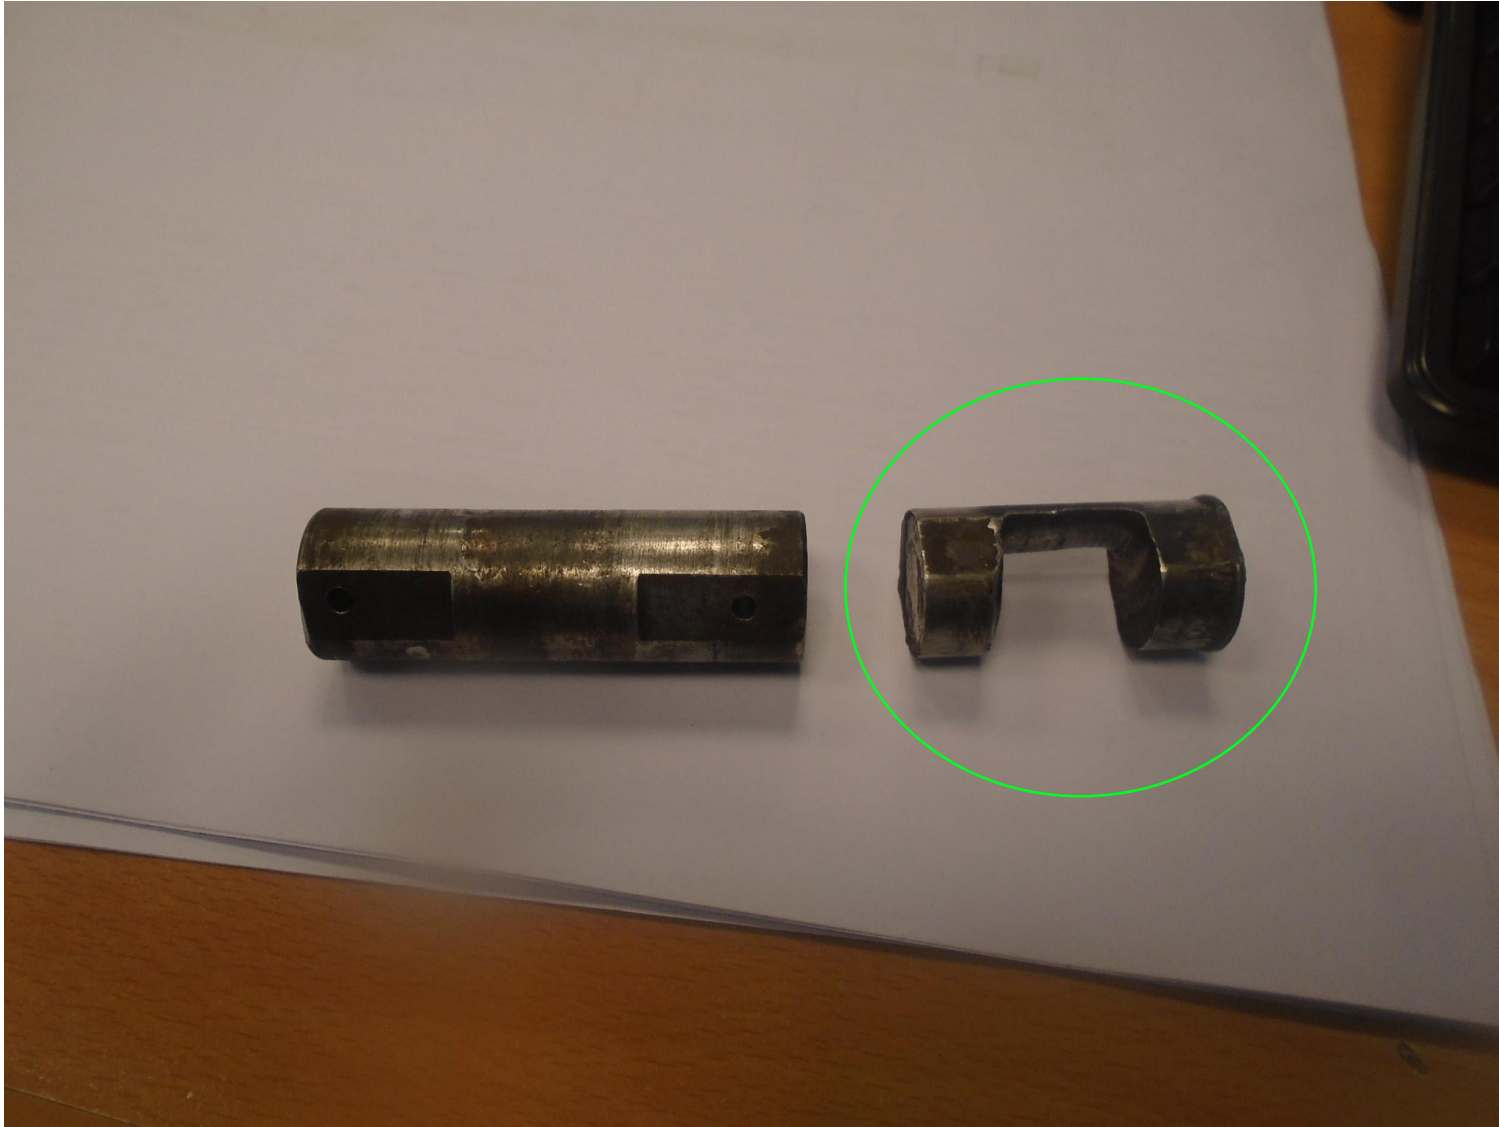
Elevator chain link's pin badly worn out

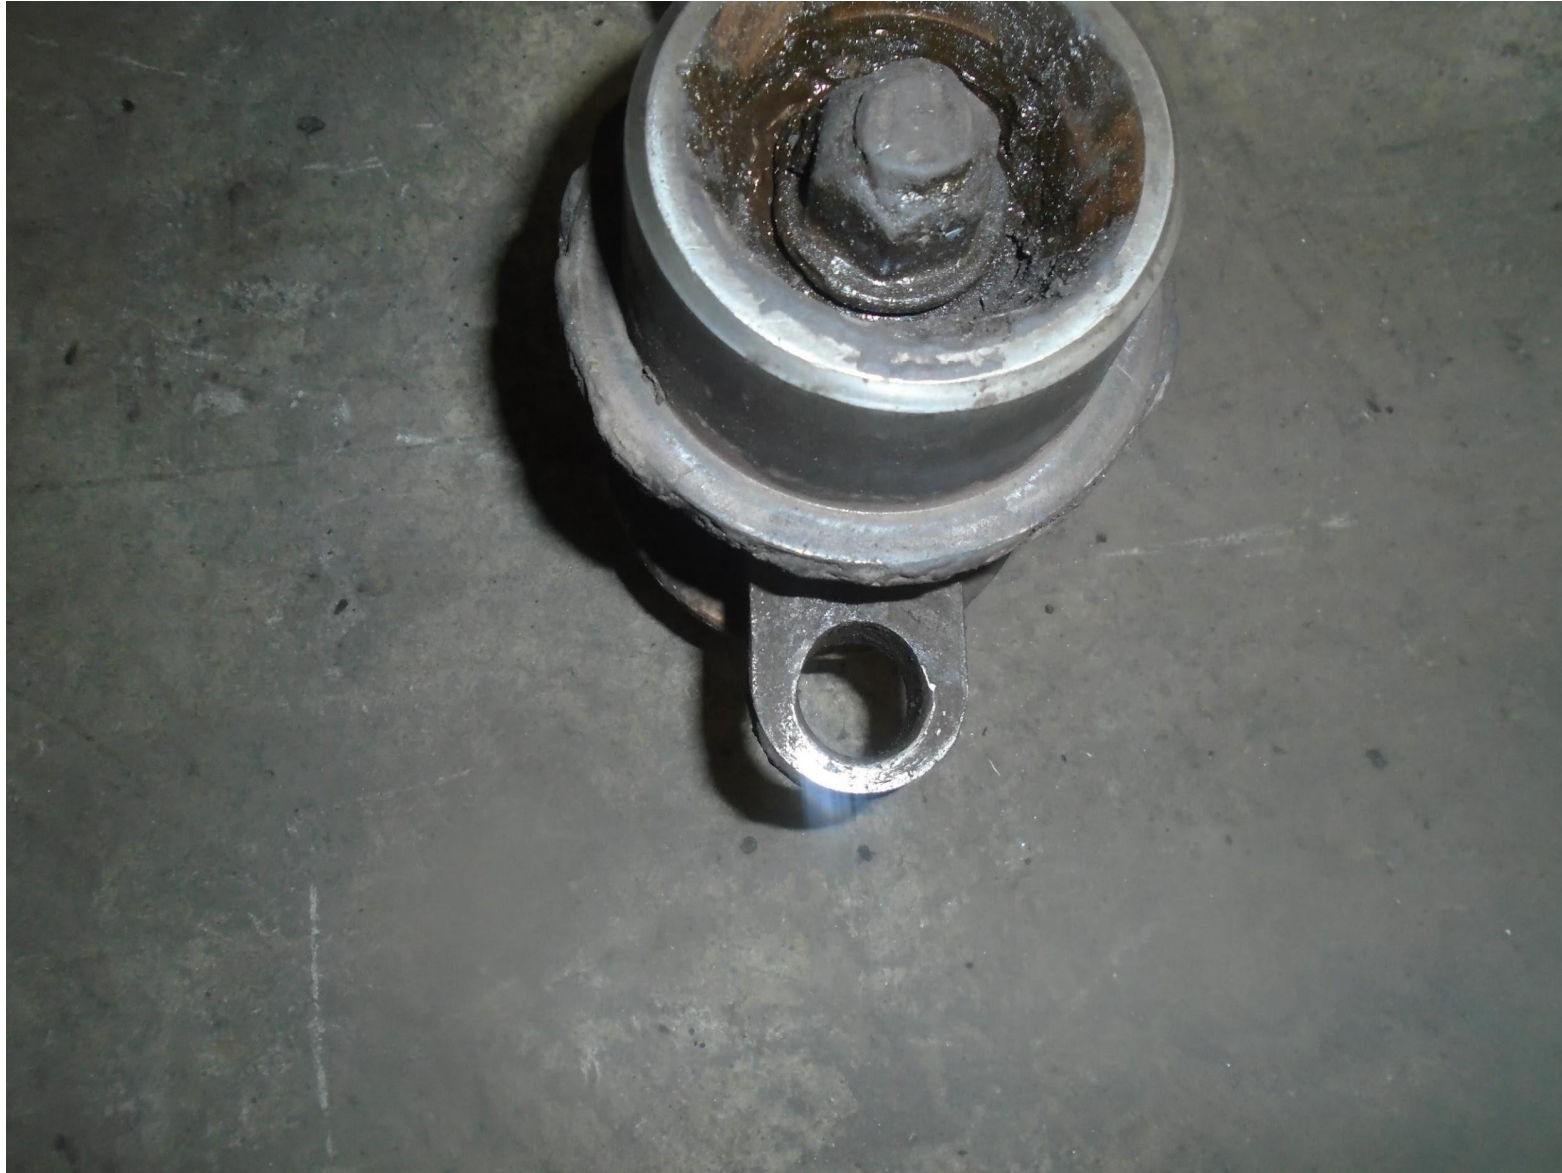
Elevator chain link's pin hole badly worn out

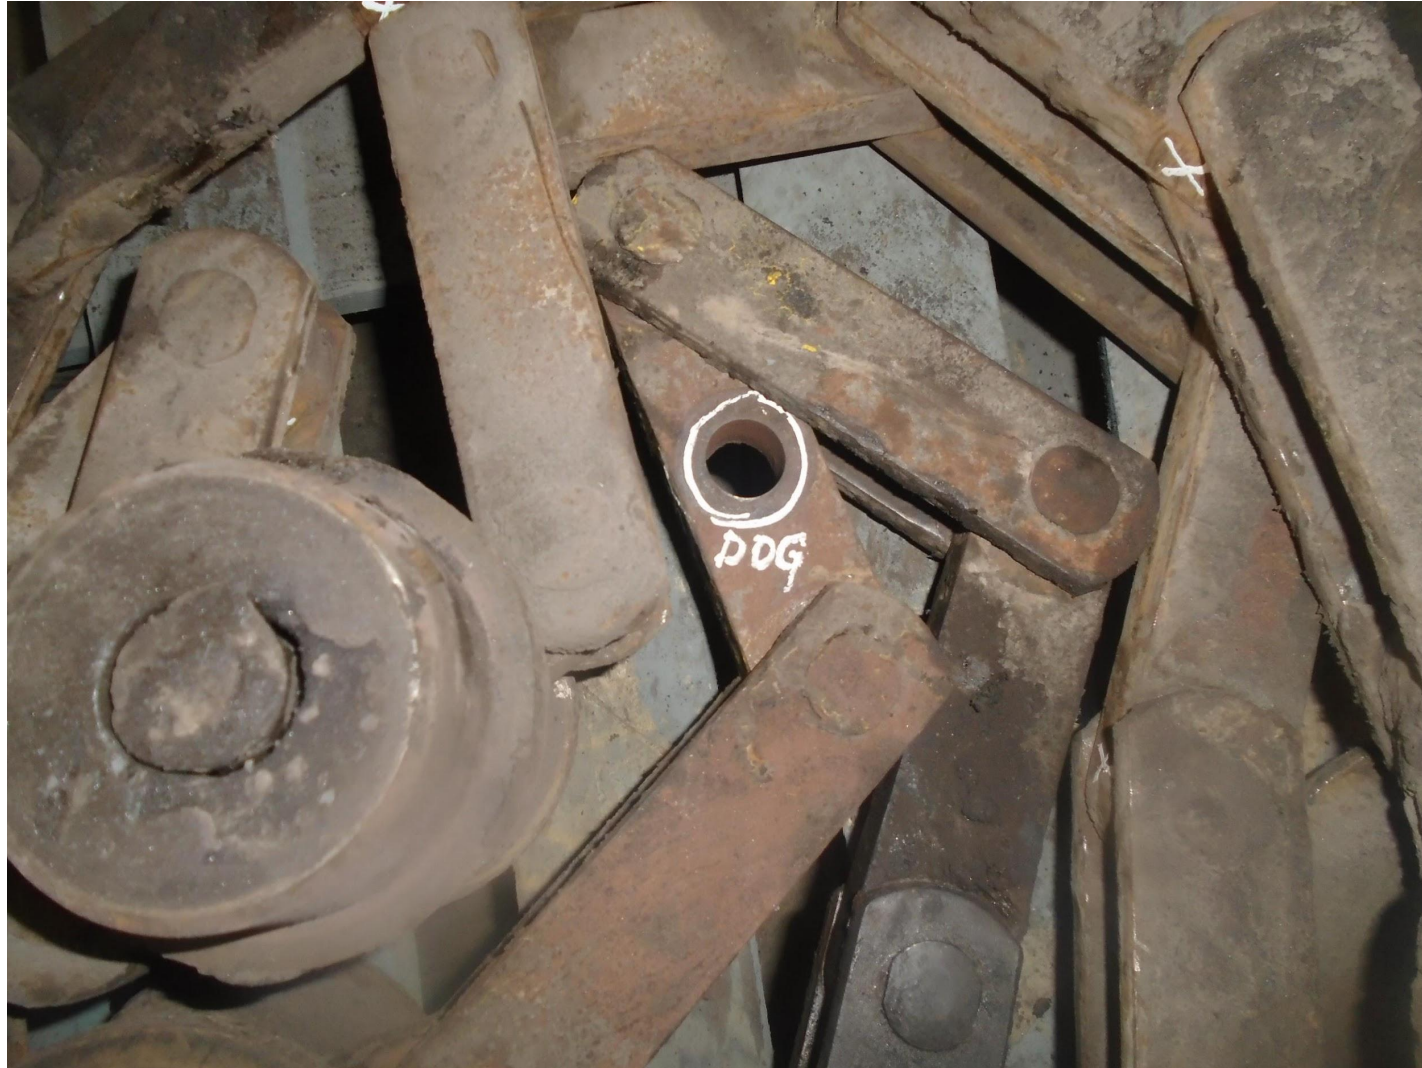
Dog mounting shaft hole badly worn out

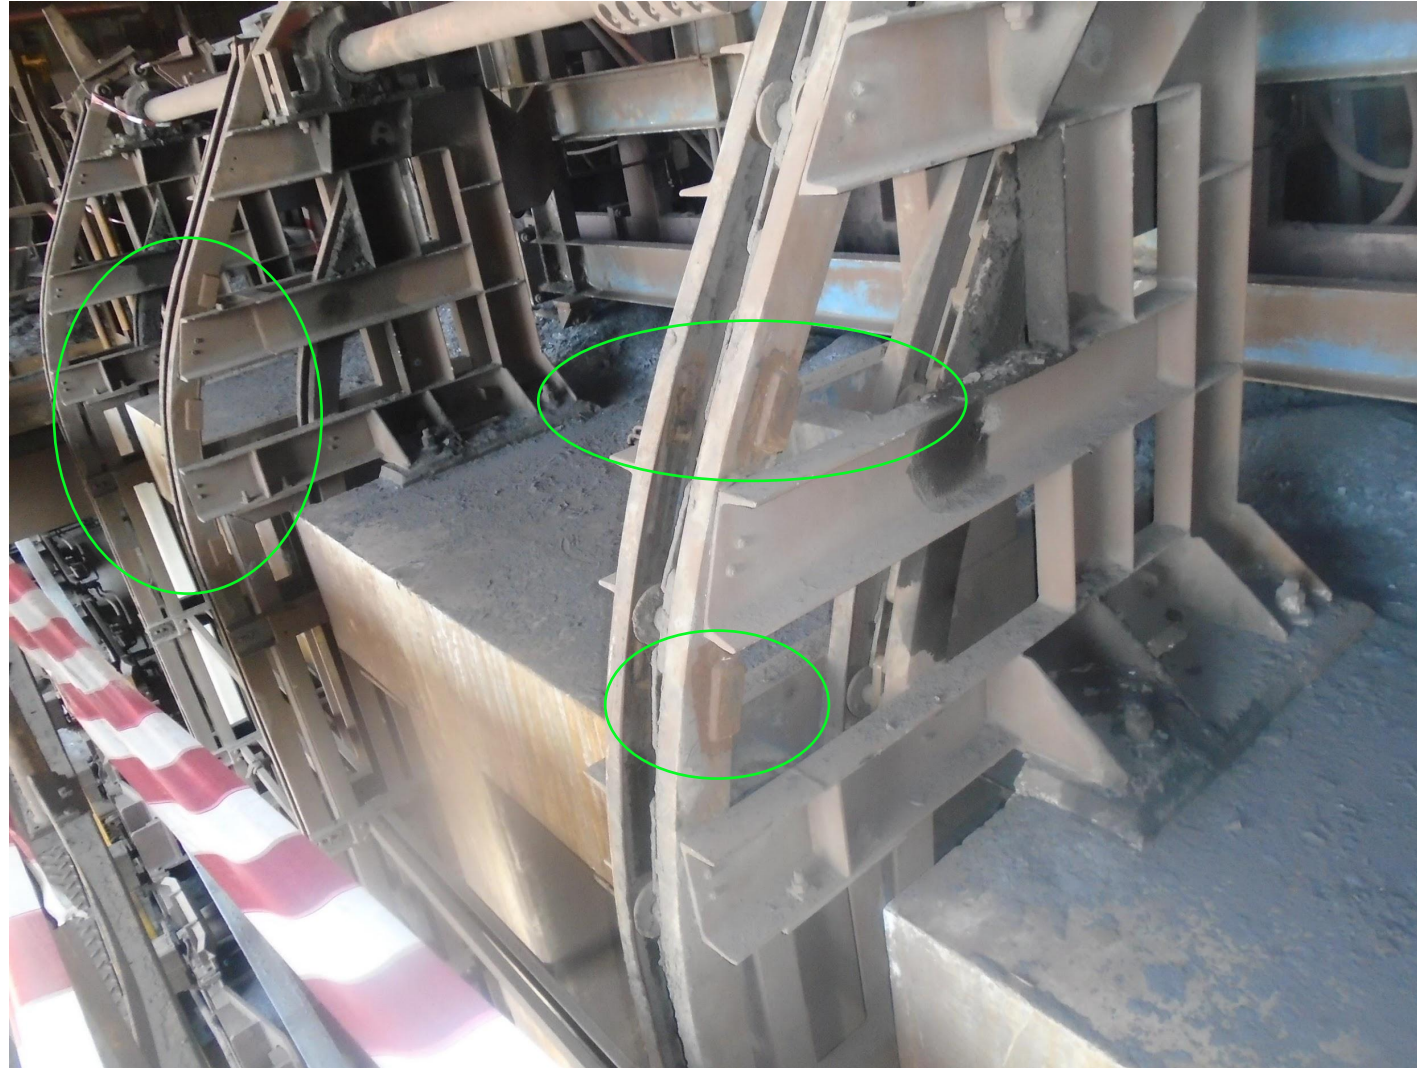
CHAIN GUIDES DAMAGED
